SITE AUDIT REPORT FOR SAS 304

15-33 BRIGHTON AVENUE, CROYDON PARK, NSW

Prepared for Andree Shehadeh of Dyldam | 6 March 2020

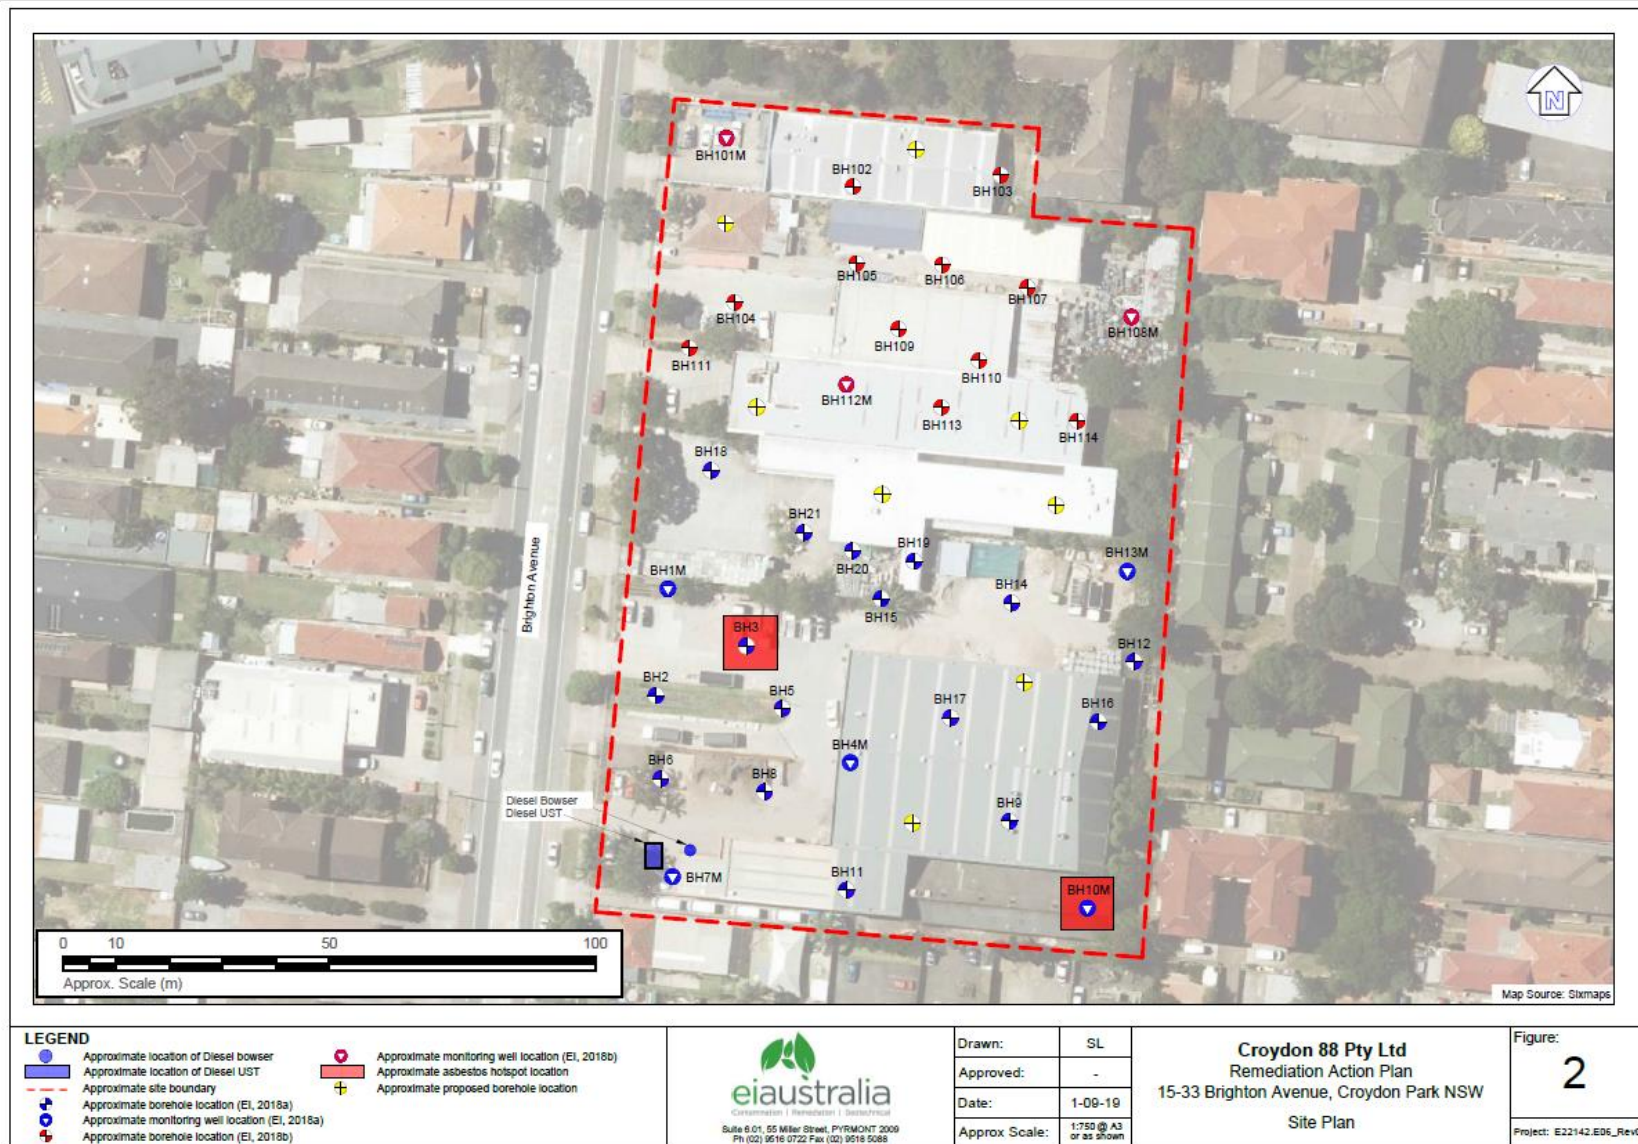
Figure 4: Locations of boreholes, monitoring wells, asbestos hotspots and UST locations. In addition, the proposed boreholes to be drilled during the data gap investigation are shown in yellow.

As noted by the Auditor in Interim Advice 01, data gaps exist due to areas of the site being inaccessible at the time of soil and groundwater investigations. Supplementary investigations to close the data gaps involve:

- Inspection and soil sampling of (building) areas with ACMs on the surface, if encountered;
- Soil sampling at a density that ultimately complies with the minimum density recommended under the EPA (1995) Sampling Design Guidelines, focusing on the former building footprints and pavements (e.g. 17 Brighton Avenue).

- Delineation of the asbestos-impacted areas (i.e. the vicinities of EIA (2018) sampling locations BH3 and BH10M;
 - A minimum of four sampling locations is recommended per hotspot (within 2-5m radius)
- Sample analyses for the identified contaminants of concern:
 - Soil (remediation areas): heavy metals (arsenic, cadmium, chromium, copper, lead, mercury, nickel and zinc), TRH's, VOC's (including the monocyclic aromatic hydrocarbons BTEX) and asbestos.
 - Soil (building footprints and pavements): heavy metals (arsenic, cadmium, chromium, copper, lead, mercury, nickel and zinc), TRH's, VOC's (including BTEX), PAH's, OCP's/OPP's, PCB's and asbestos.

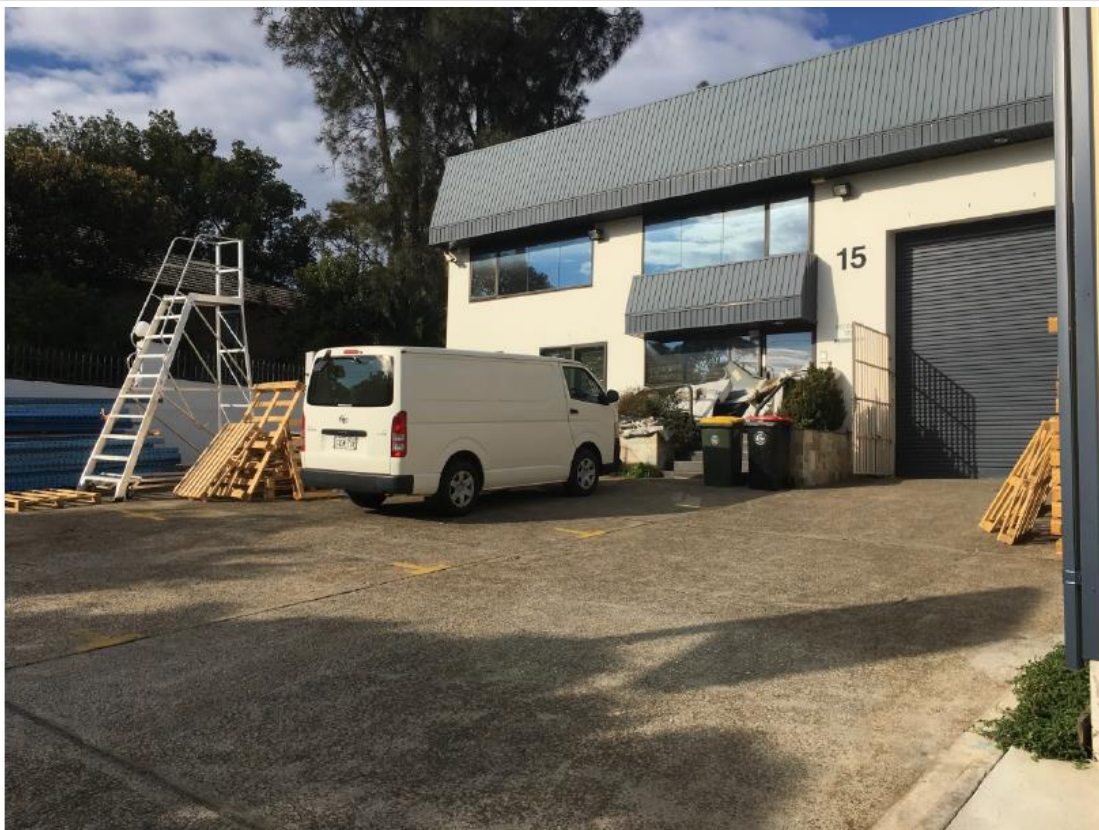
Photograph 1: Western/front façade of the commercial warehouse located at 15 Brighton Avenue.

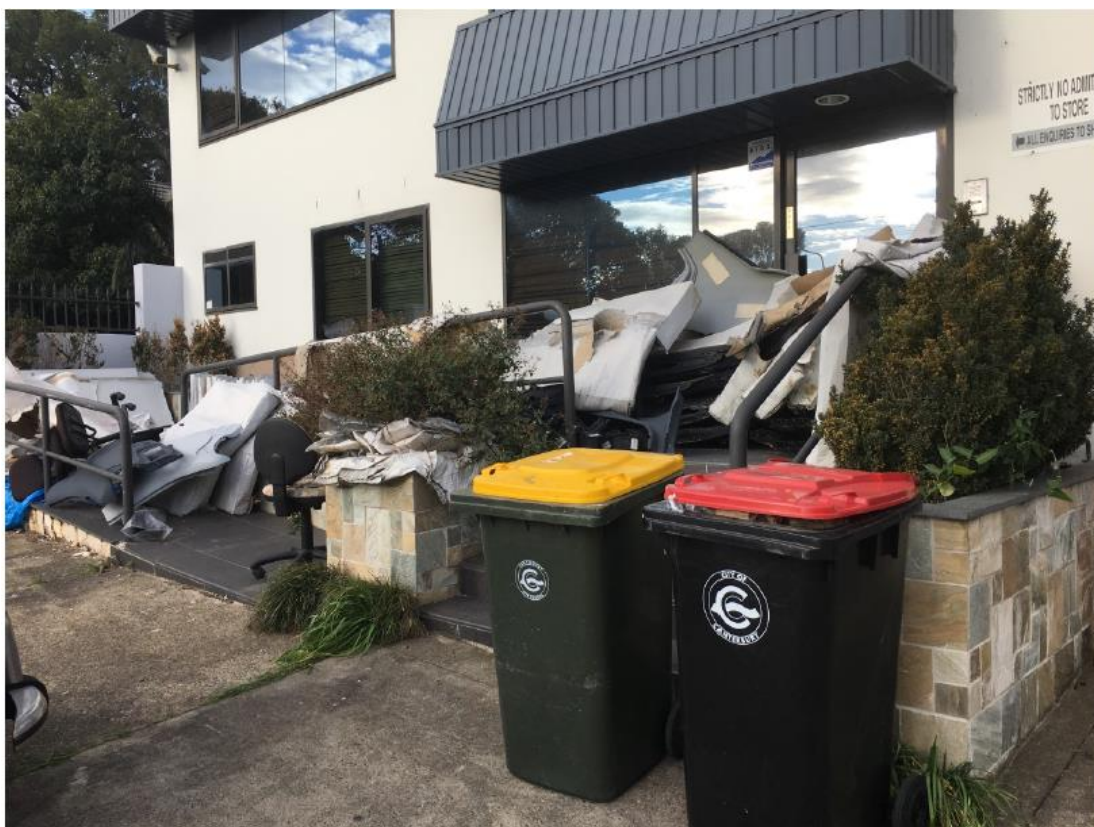
Photograph 2: Commercial rubbish accumulated west of 15 Brighton Avenue.

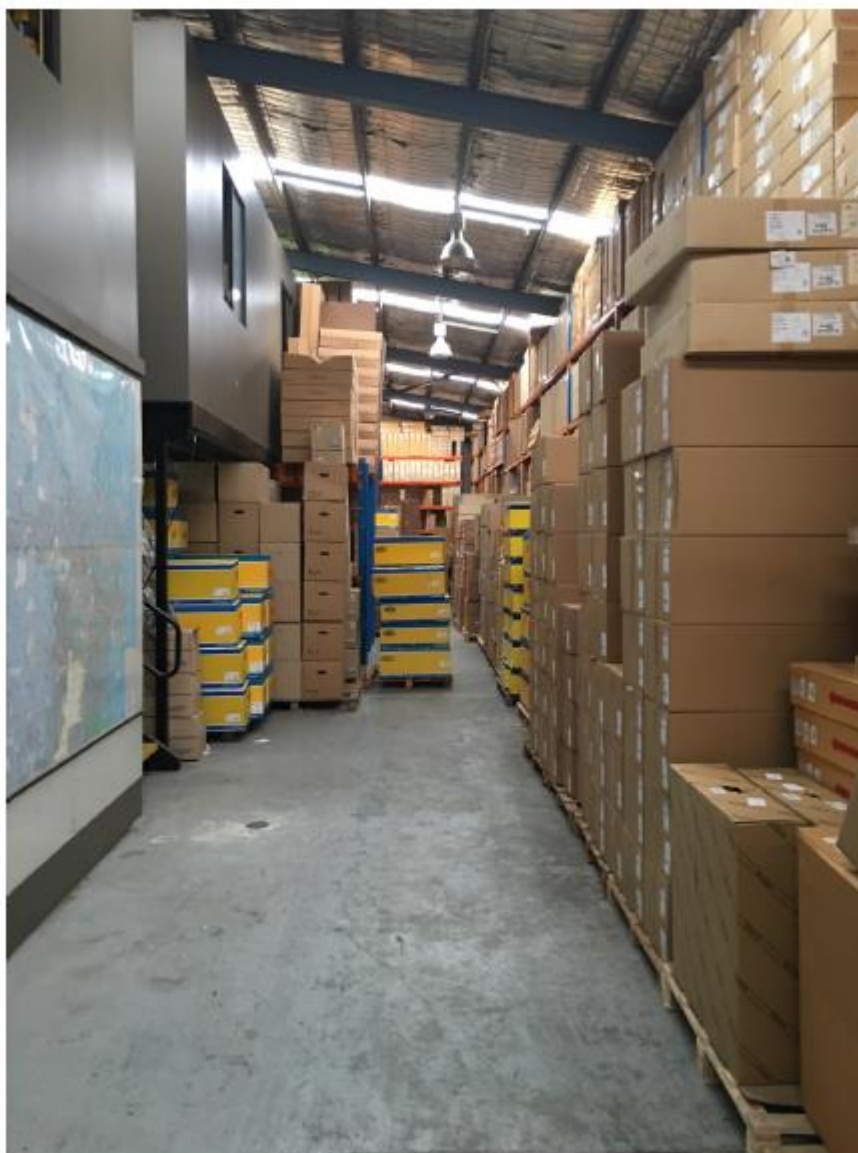
Photograph 3: Conditions inside the commercial warehouse located at 15 Brighton Avenue.

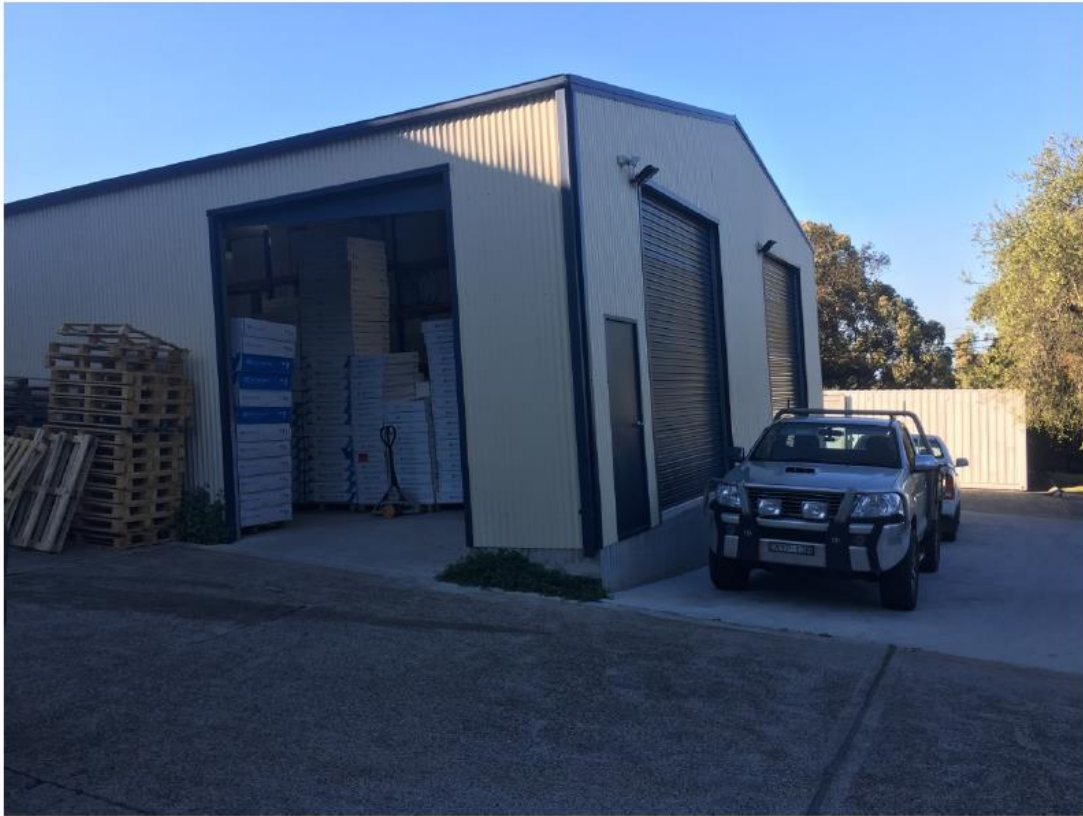
Photograph 4: The new commercial warehouse located in the Westernmost portion of 17 Brighton Avenue.

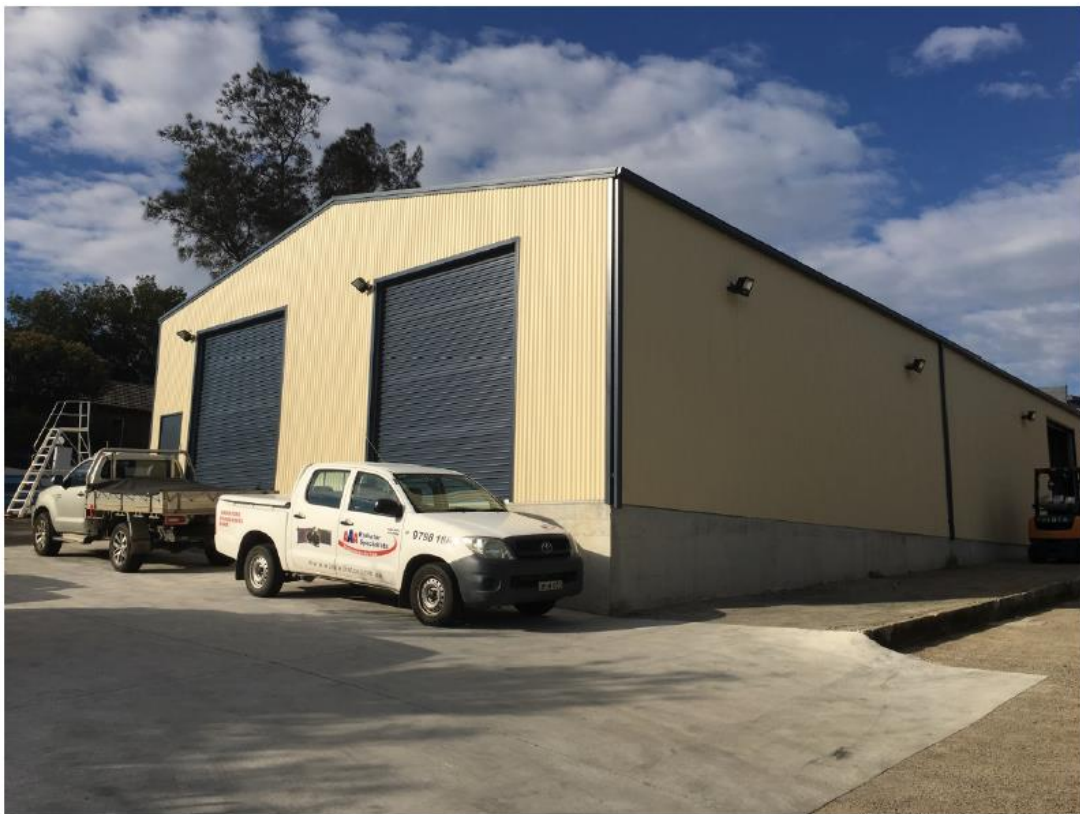
Photograph 5: Concrete hardstand and the external conditions of 17 Brighton Avenue.

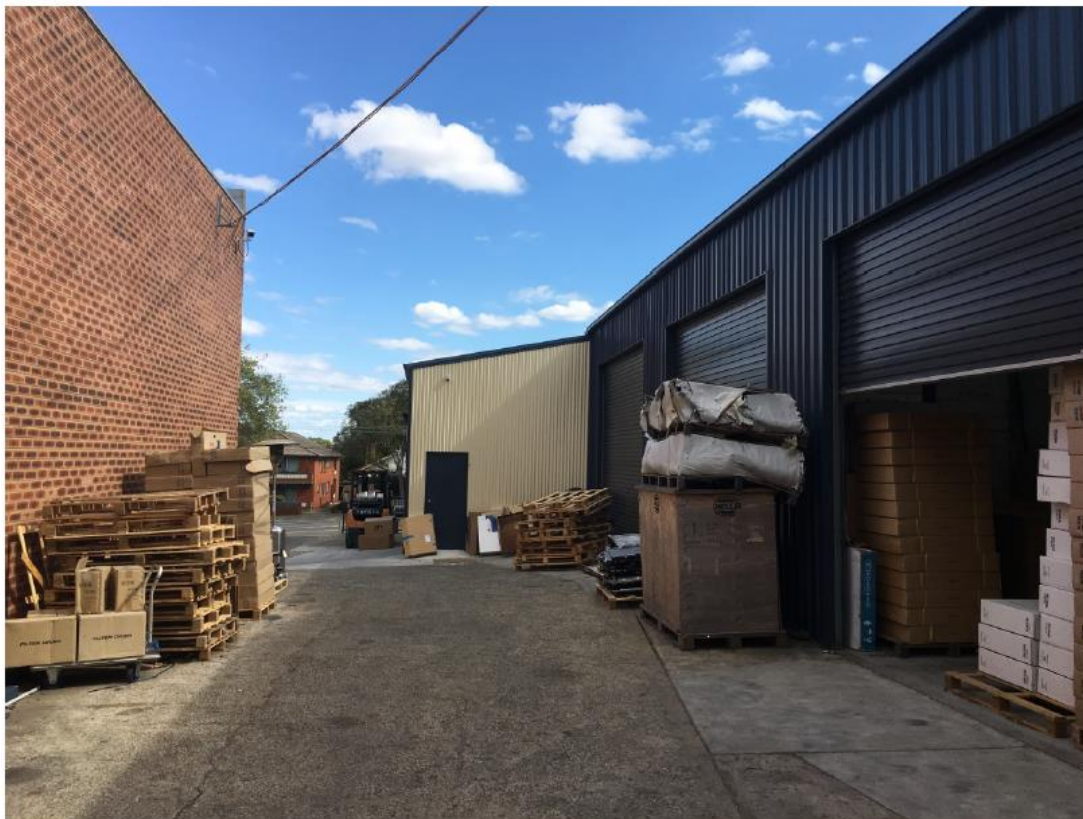
Photograph 6: Warehouse located in the middle of 17 Brighton Avenue.

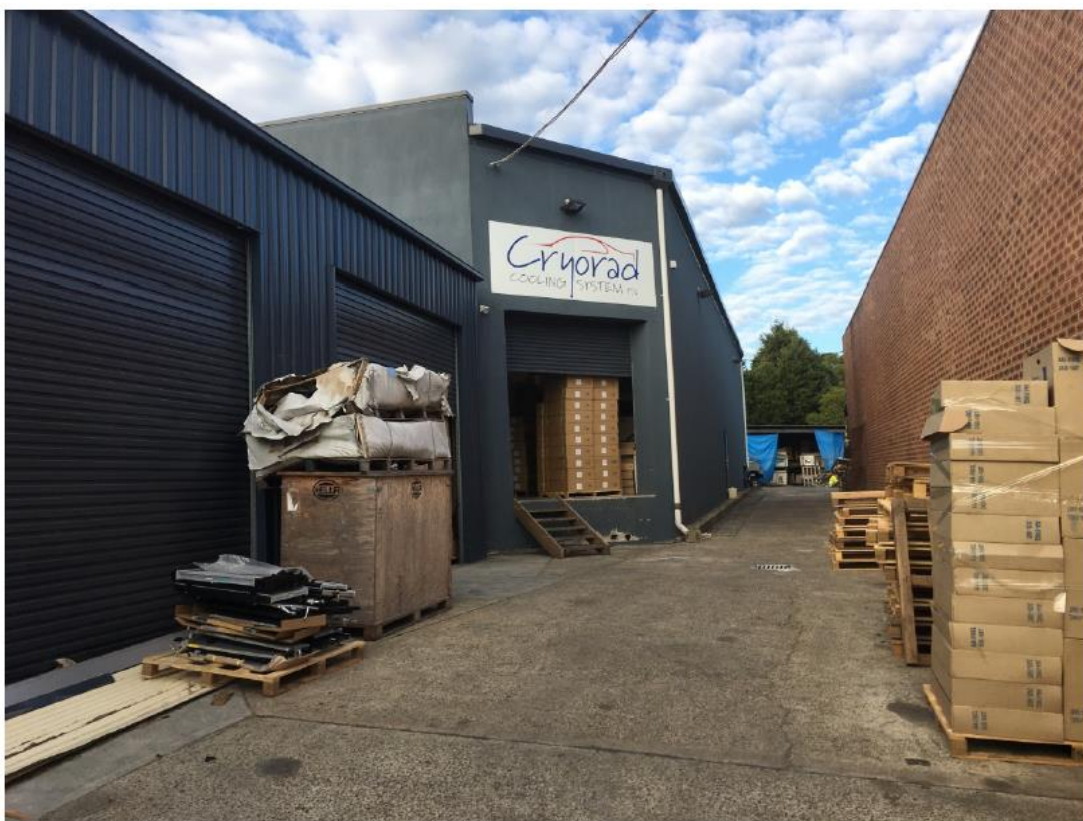
Photograph 7: Eastern view of the site from the middle of 17 Brighton Avenue.

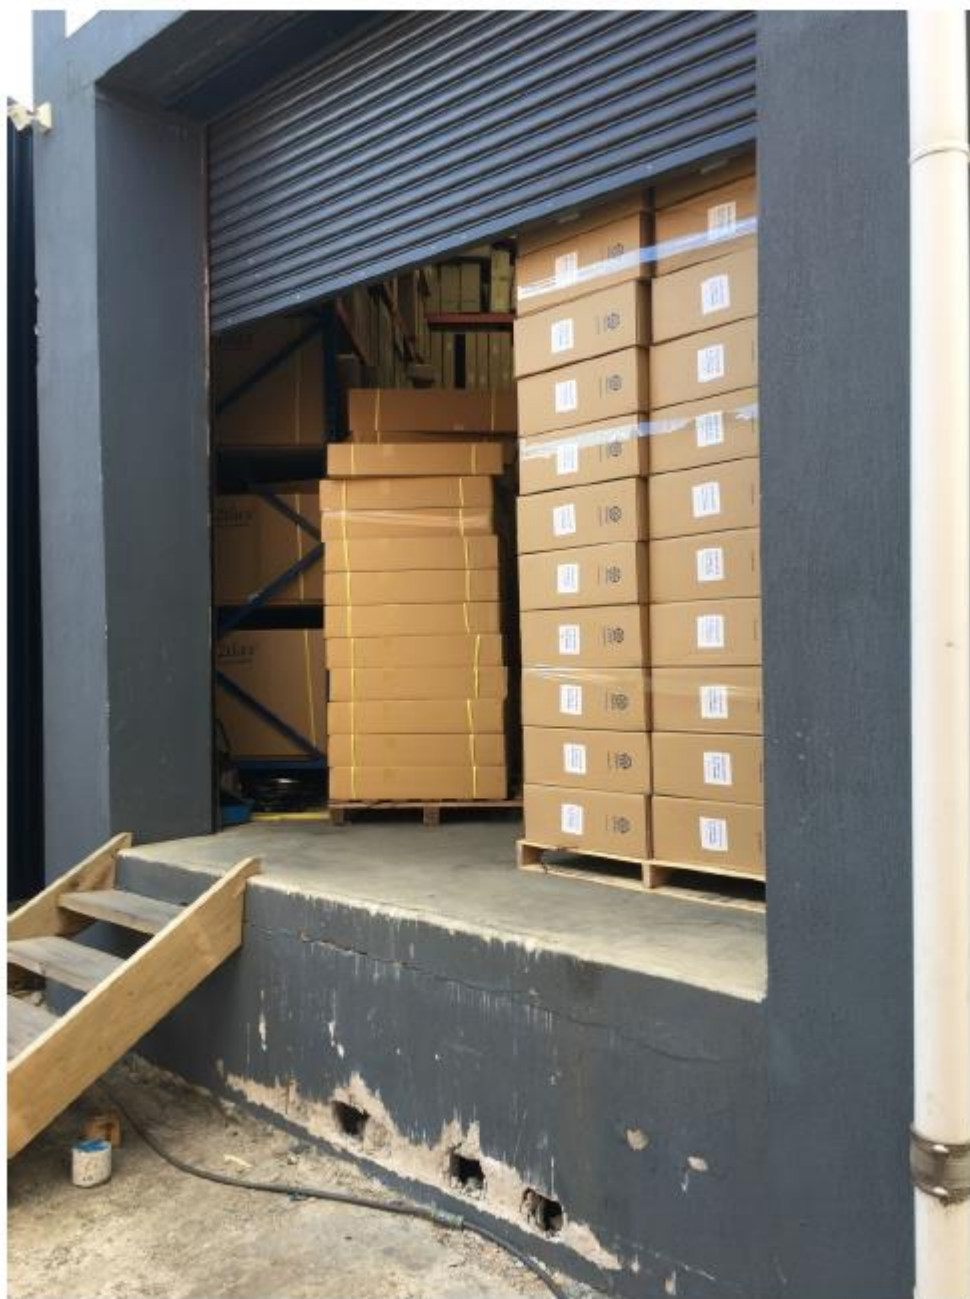
Photograph 8: Easternmost warehouse on 17 Brighton Avenue.

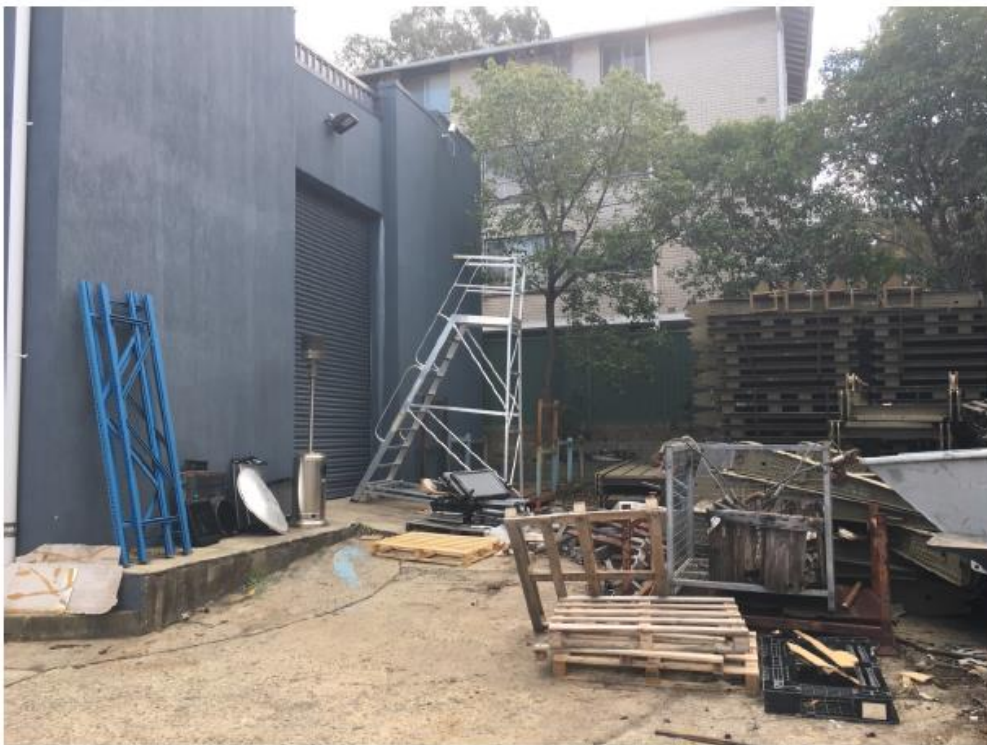
Photograph 9: East of the third warehouse located on 17 Brighton Avenue.

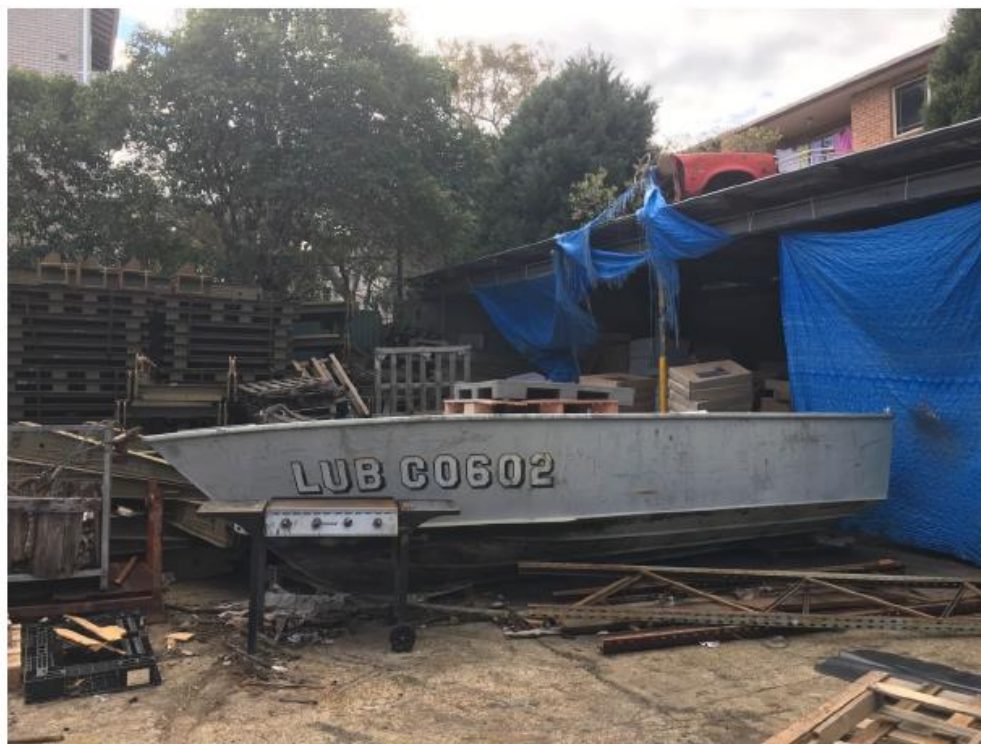
Photograph 10: Material accumulated east of the third warehouse at 17 Brighton Avenue.

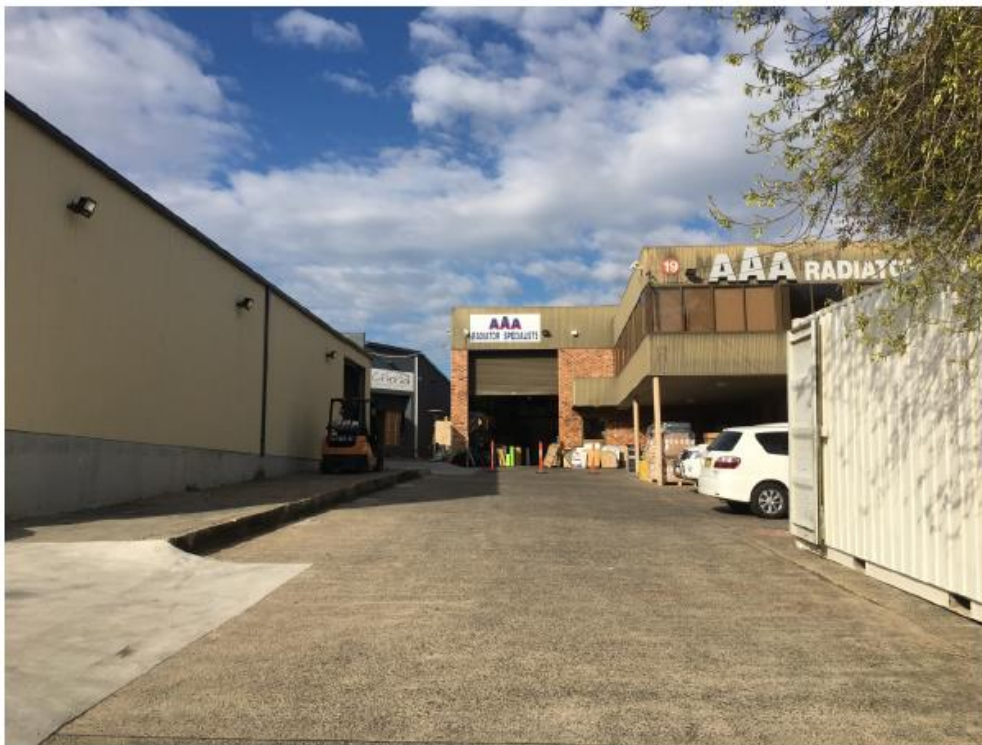
Photograph 11: Western portion of 19 Brighton Avenue.

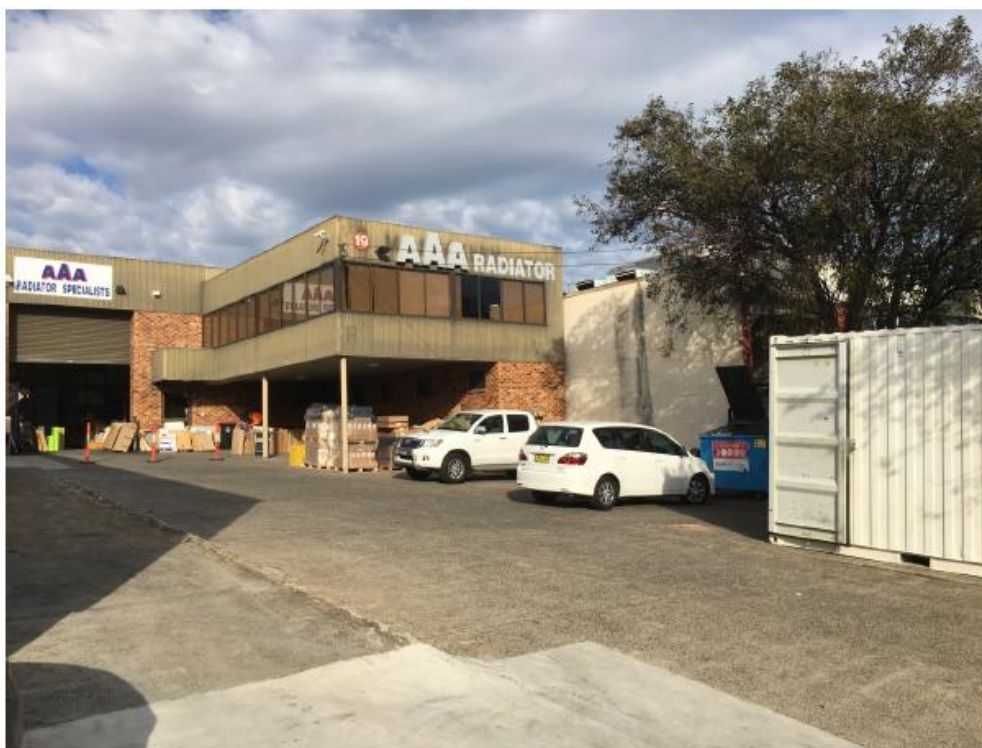
Photograph 12: Concrete hardstand west of warehouse located at 19 Brighton Avenue.

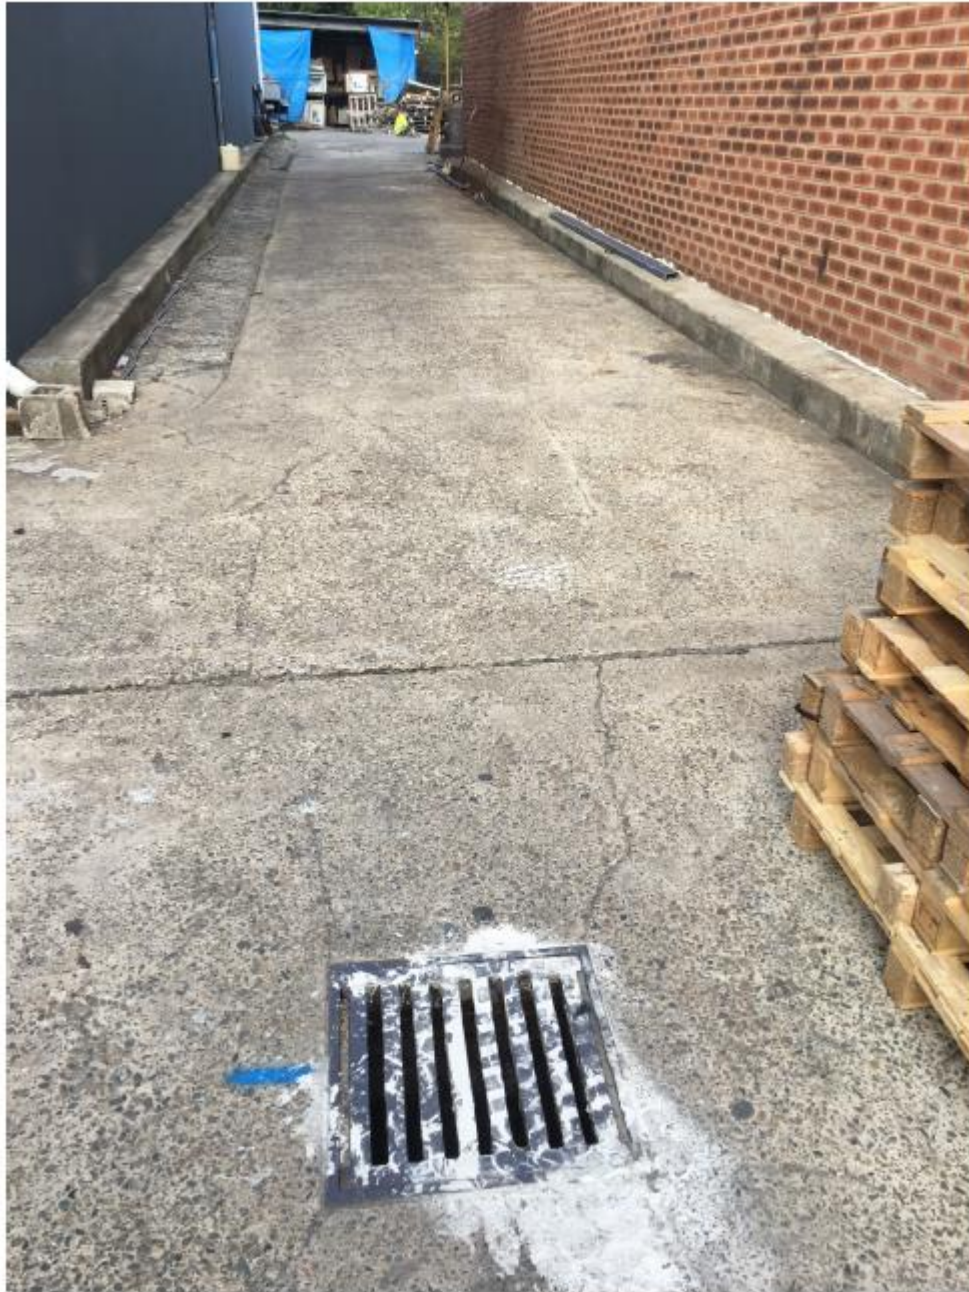
Photograph 13: Stormwater drain in between the warehouses at 17 & 19 Brighton Avenue, running parallel to the buildings.

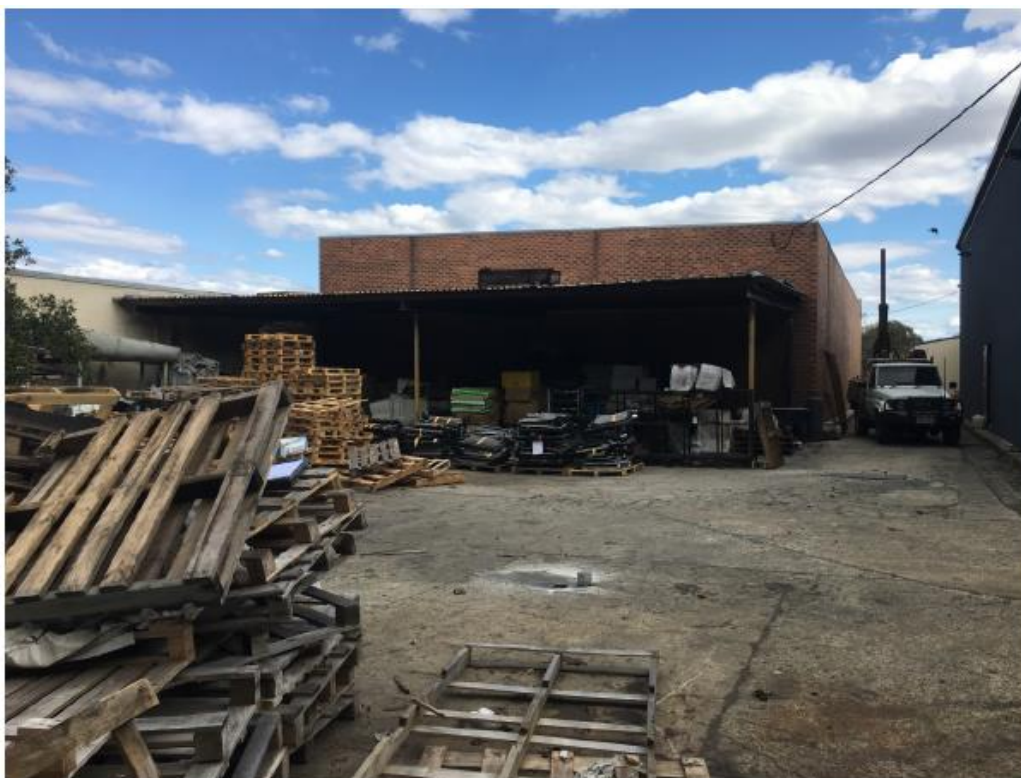
Photograph 14: Material accumulated east of the warehouse located at 19 Brighton Avenue.

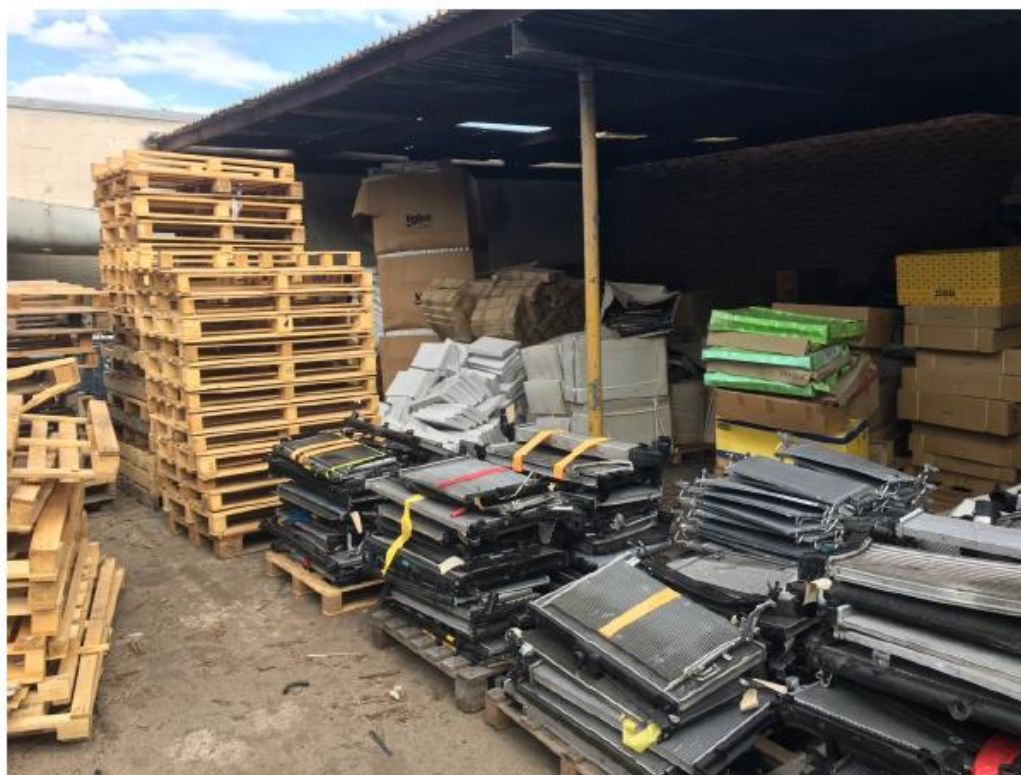
Photograph 15: Excess radiator parts and timber pallets accumulated east of 19 Brighton Avenue.

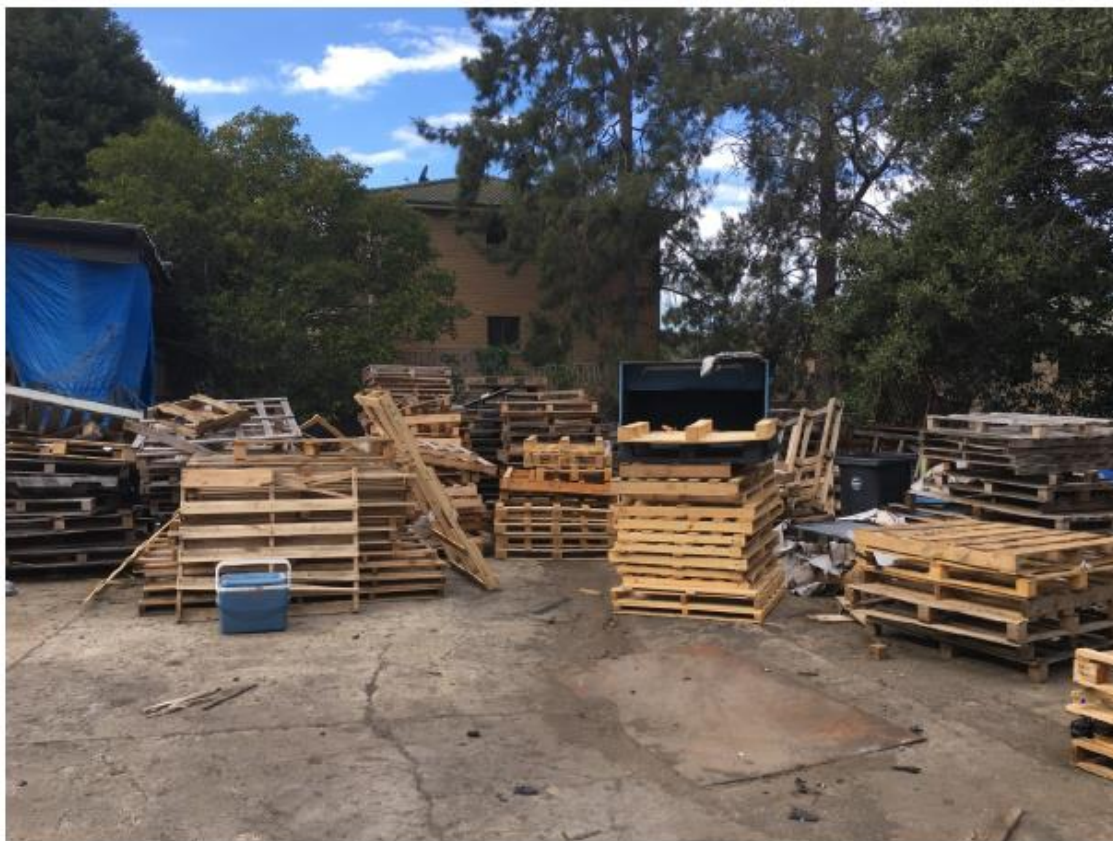
Photograph 16: Timber pallets accumulated east towards the site boundary at 19 Brighton Avenue.

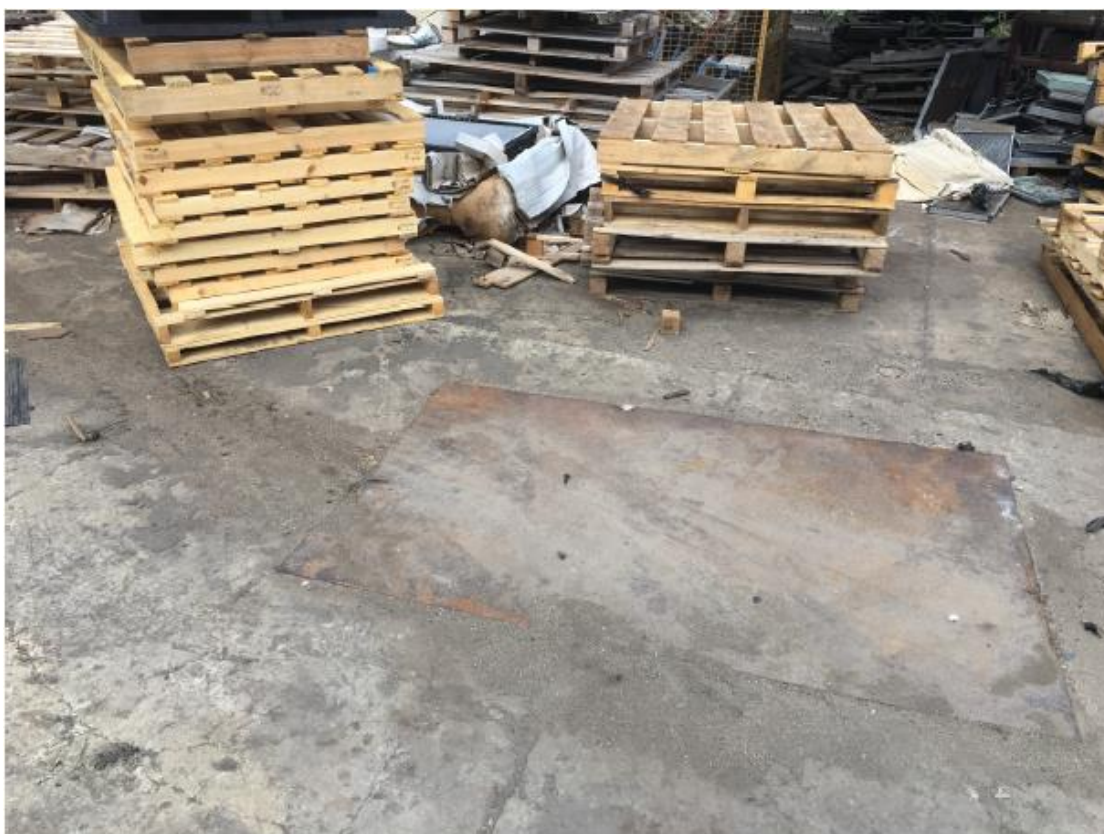
Photograph 17: Stormwater pit located east of the warehouse at 19 Brighton Avenue.

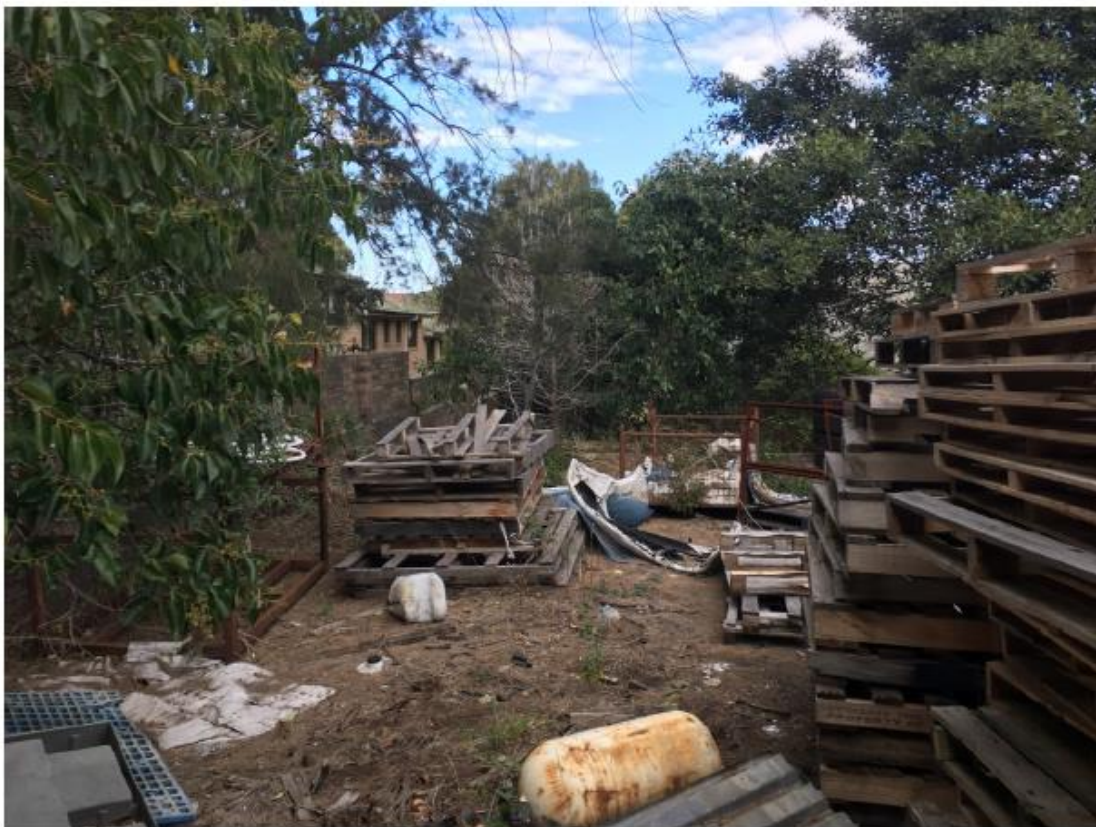
Photograph 18: Overgrown/distressed vegetation along the eastern site boundary of 19 Brighton Avenue.

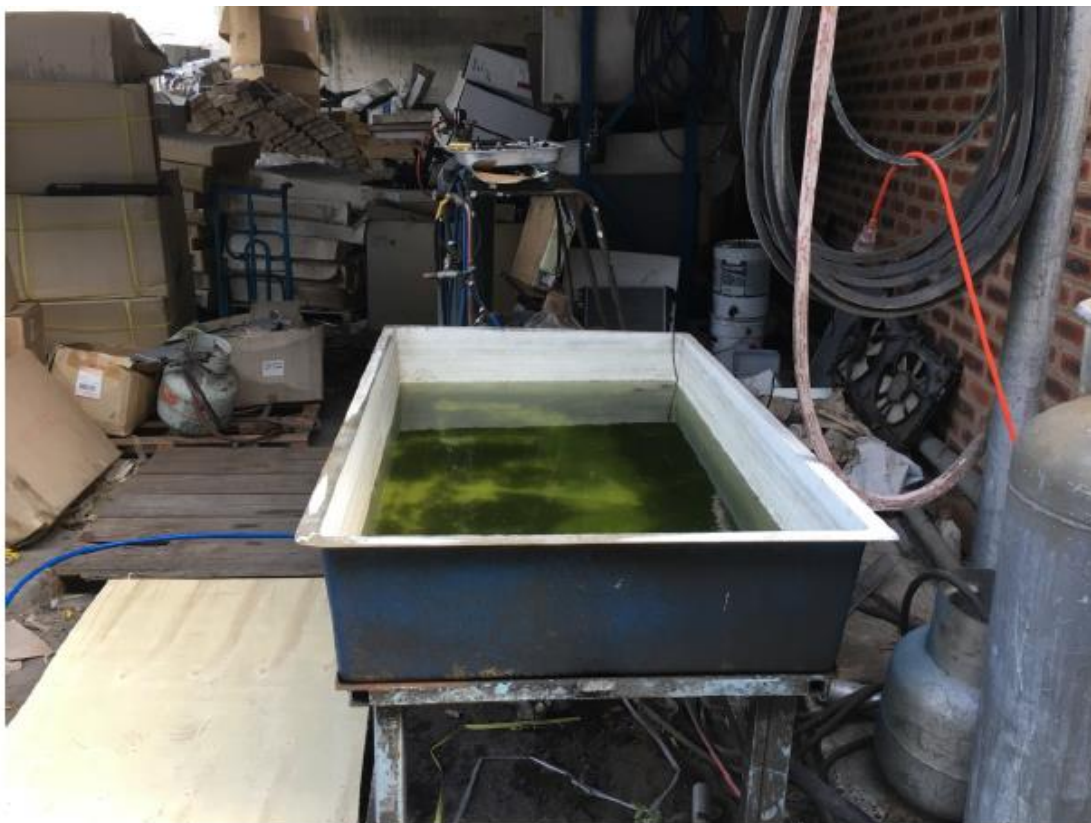
Photograph 19: Tub of mouldy water and excess waste directly adjacent 19 Brighton Avenue.

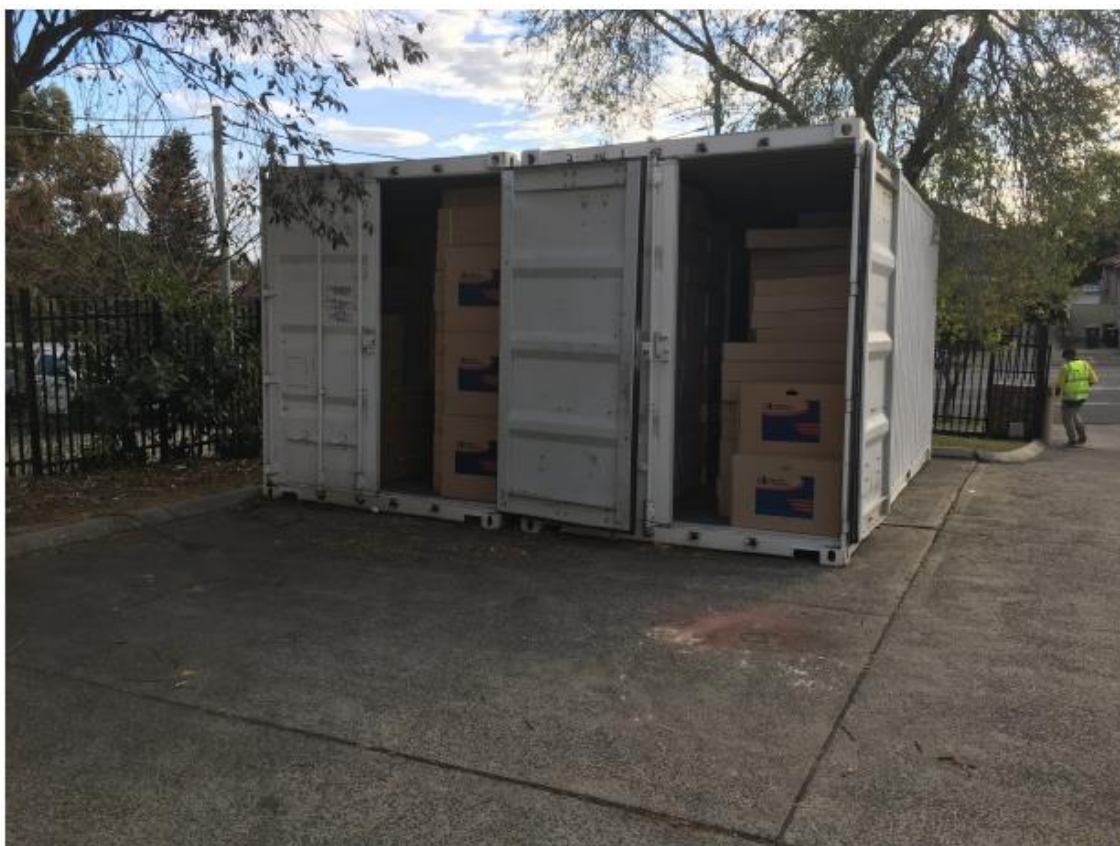
Photograph 20: Storage containers located west of the warehouse at 19 Brighton Avenue.

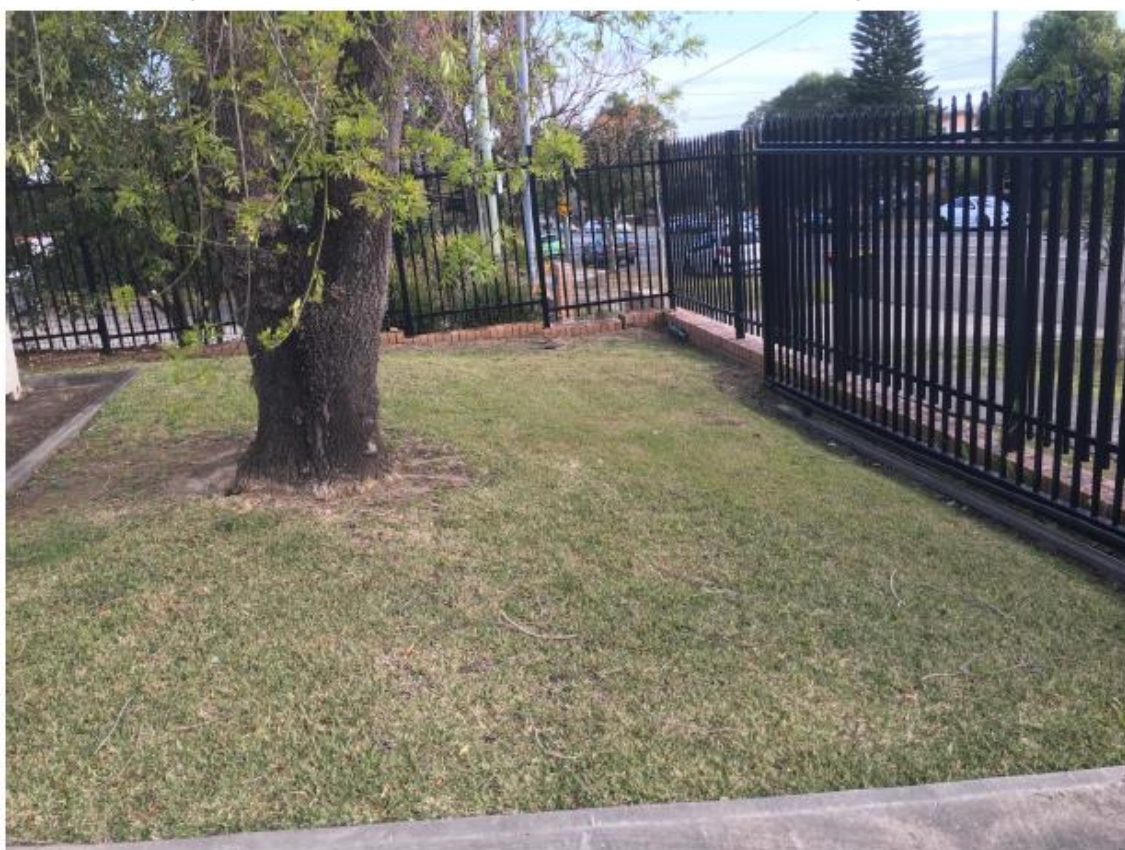
Photograph 21: Maintained grass evident along the western site boundary of 19 Brighton Avenue.

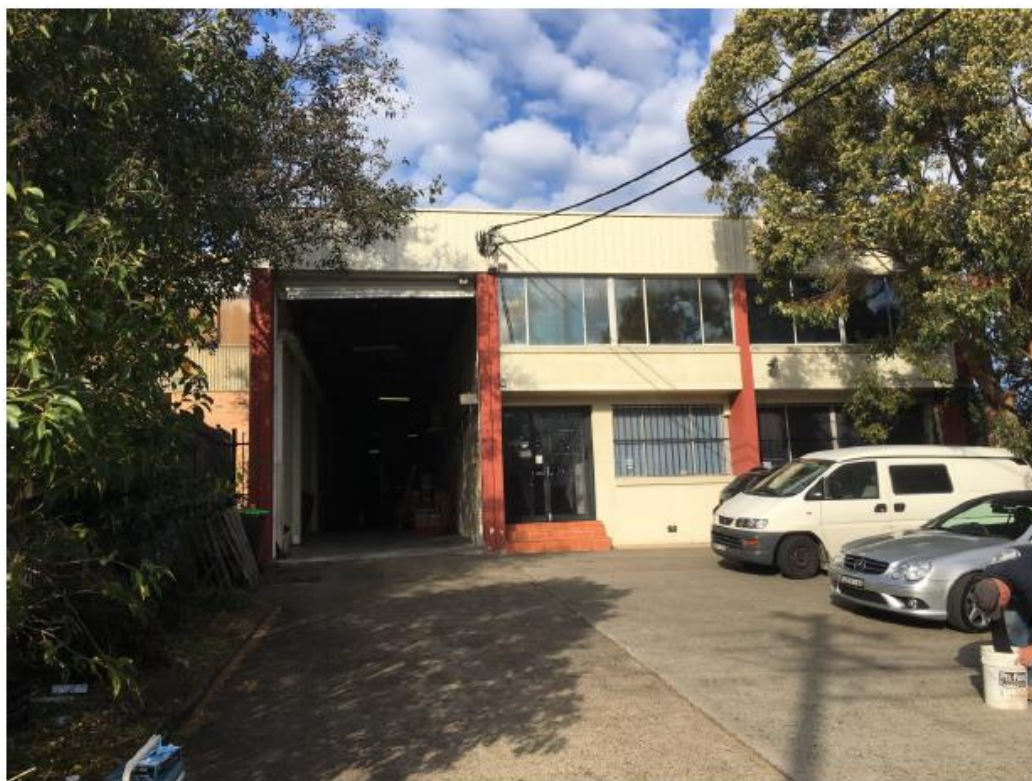
Photograph 22: Western façade of the warehouse located at 21 Brighton Avenue.
