SITE AUDIT REPORT FOR SAS 304

15-33 BRIGHTON AVENUE, CROYDON PARK, NSW

Prepared for Andree Shehadeh of Dyldam | 6 March 2020

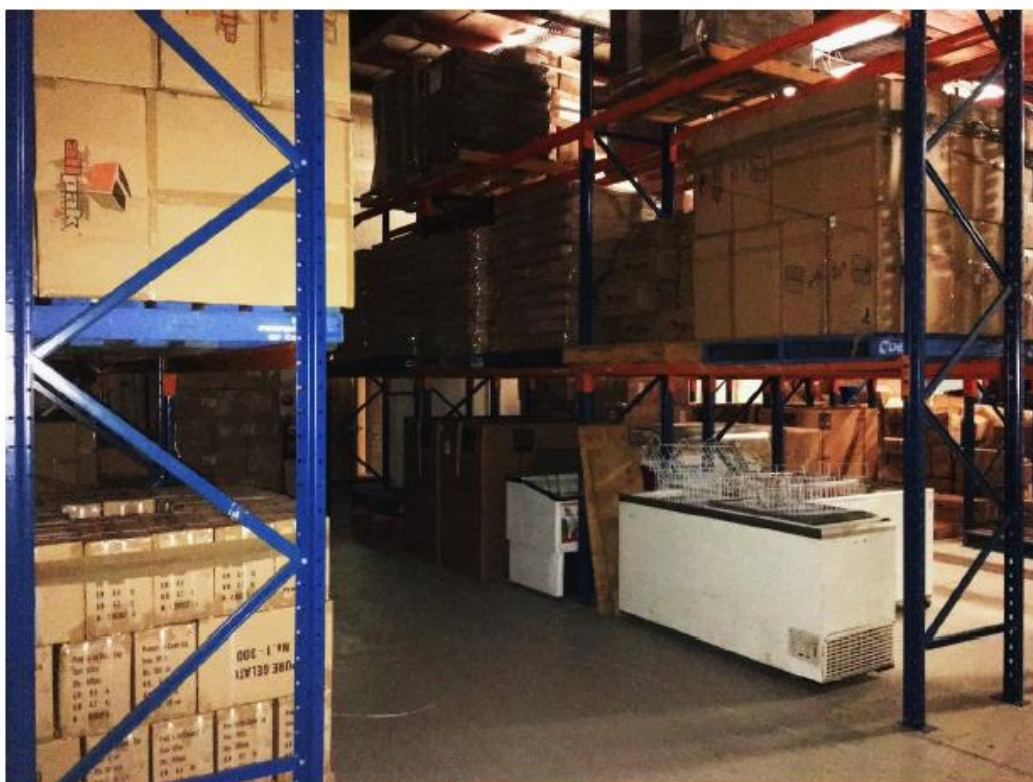
Photograph 23: Goods stored inside the warehouse located at 19 Brighton Avenue.

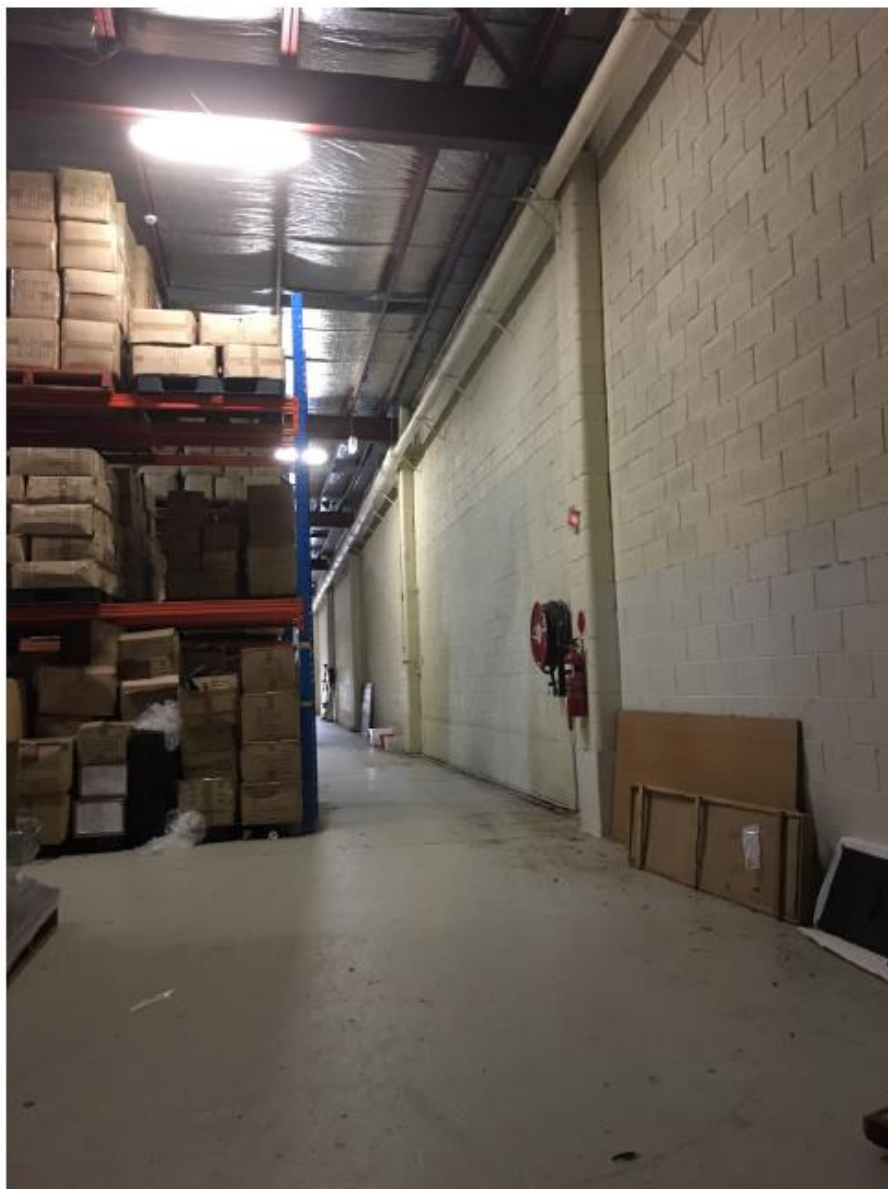
Photograph 24: Internal condition of the warehouse located at 19 Brighton Avenue.

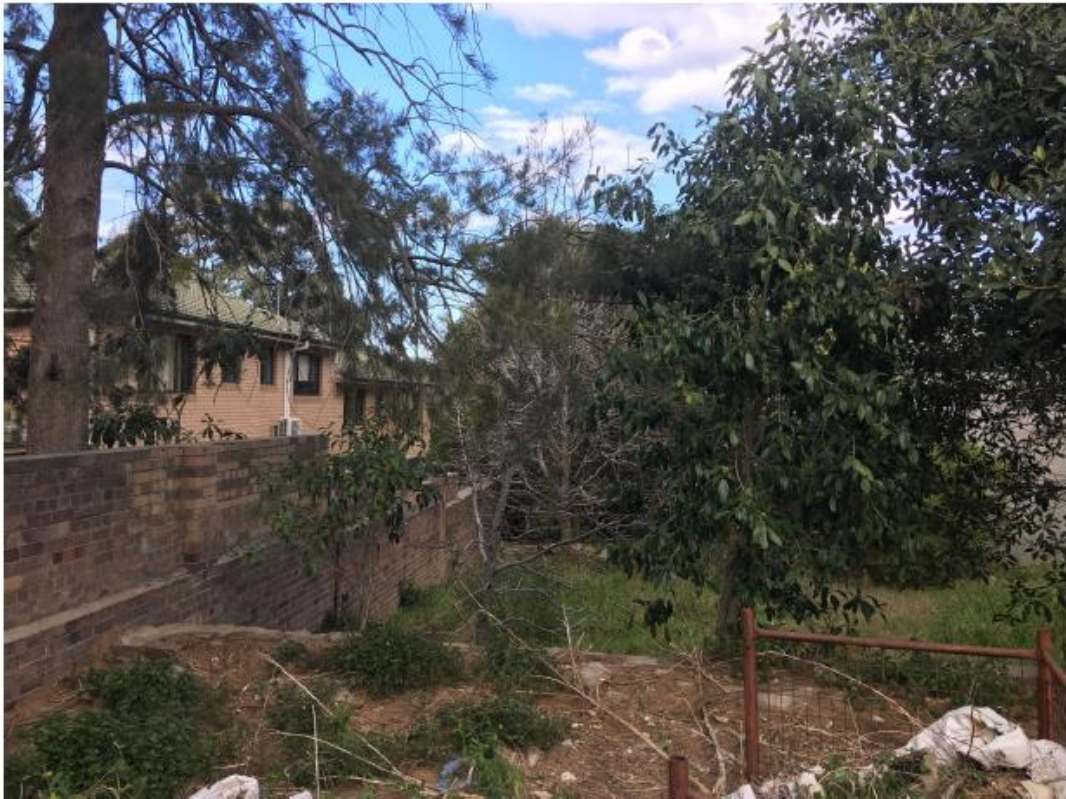
Photograph 25: Overgrown/distressed vegetation directly behind the warehouse at 21 Brighton Avenue.

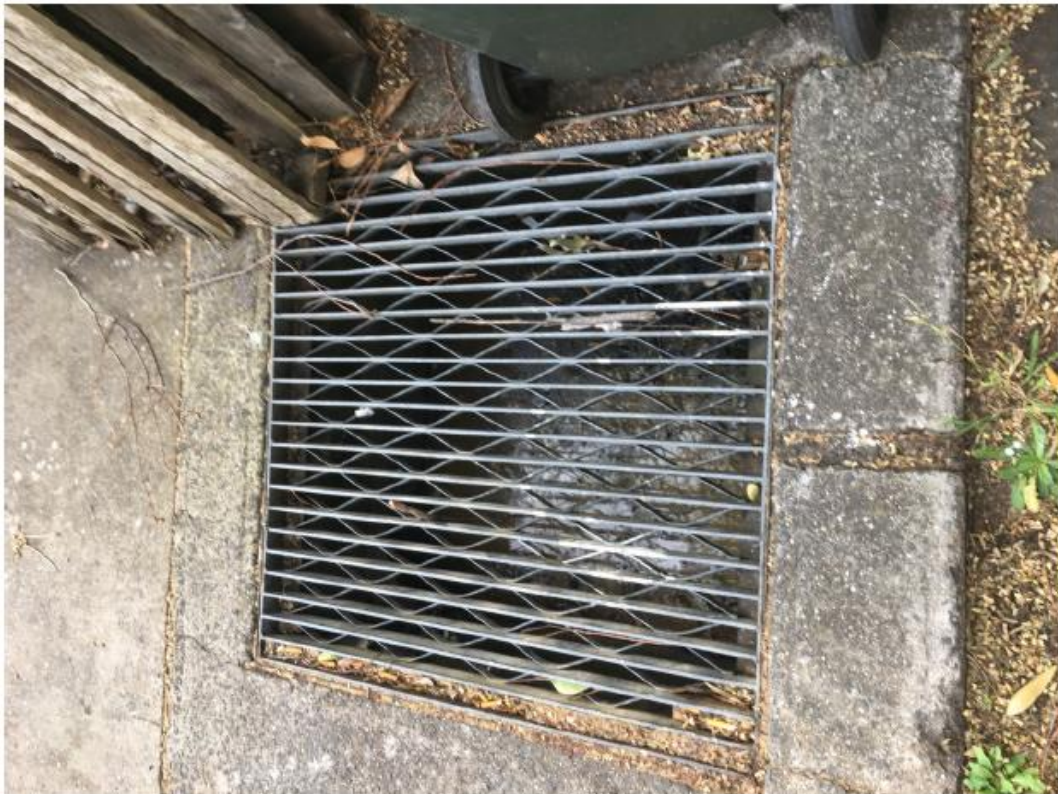
Photograph 26: Stormwater drain located directly west of the warehouse at 21 Brighton Avenue.

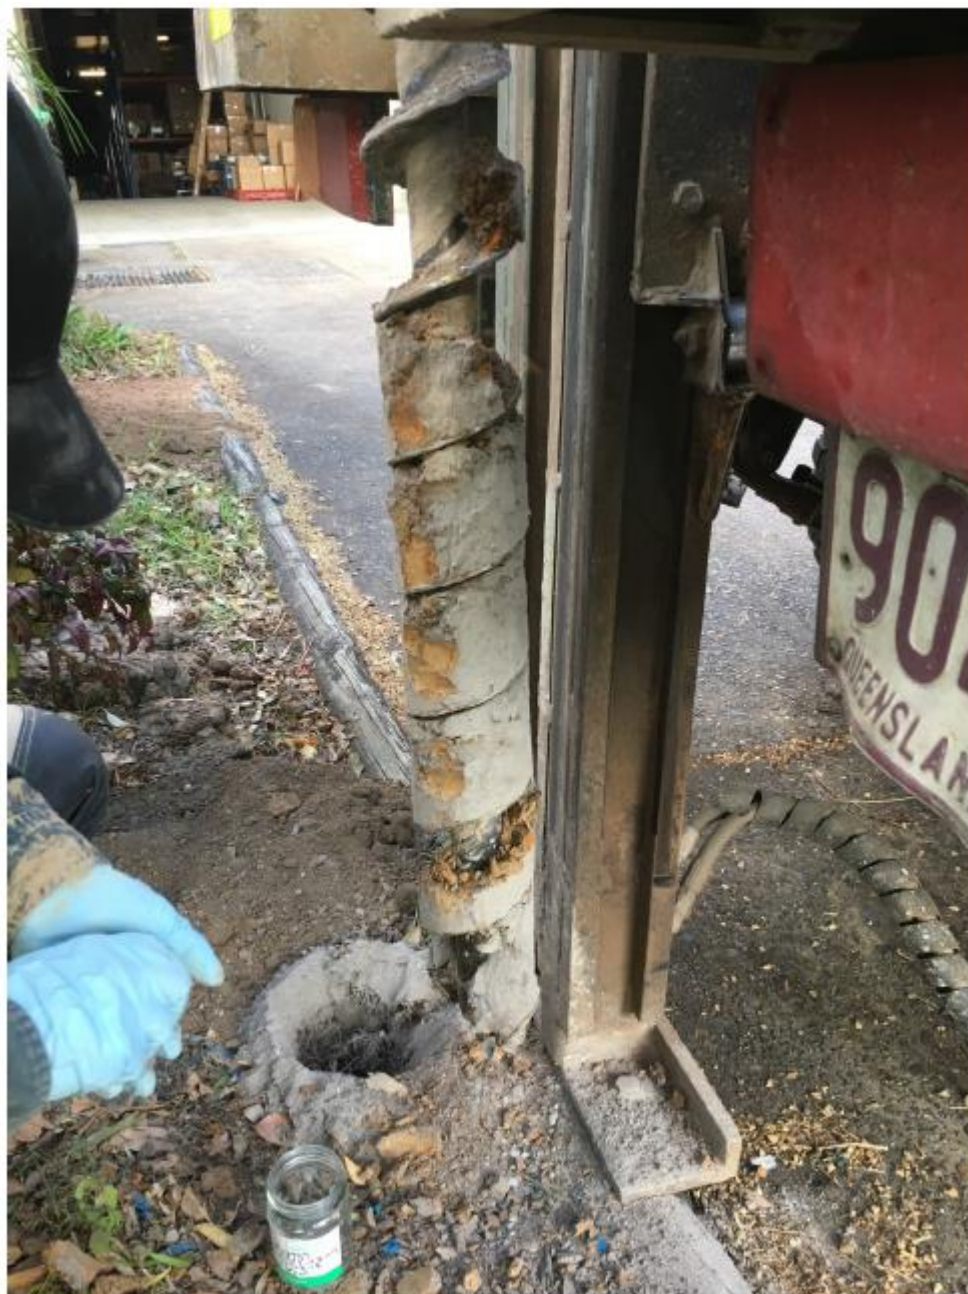
Photograph 27: Material from Borehole BH111, in the south-western portion of the site (21 Brighton Avenue).
