PRELIMINARY CONTAMINATION SCREENING AND WASTE CLASSIFICATION

PROPOSED REDEVELOPMENT OF COMPASS CENTRE

THE APPIAN WAY, BANKSTOWN, NSW

4 SEPTEMBER 2015

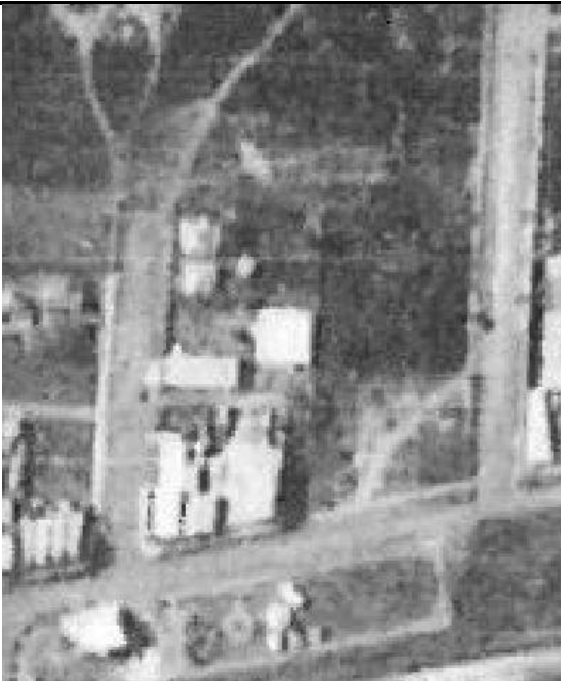
Year	Details
1930

<p>The photograph was of very poor quality. The south-west section of the site appeared to be occupied by buildings. The remaining sections of the site were vacant and grassed.</p> <p>The immediate surrounds were generally vacant with scattered buildings which appeared to be low density residences.</p>

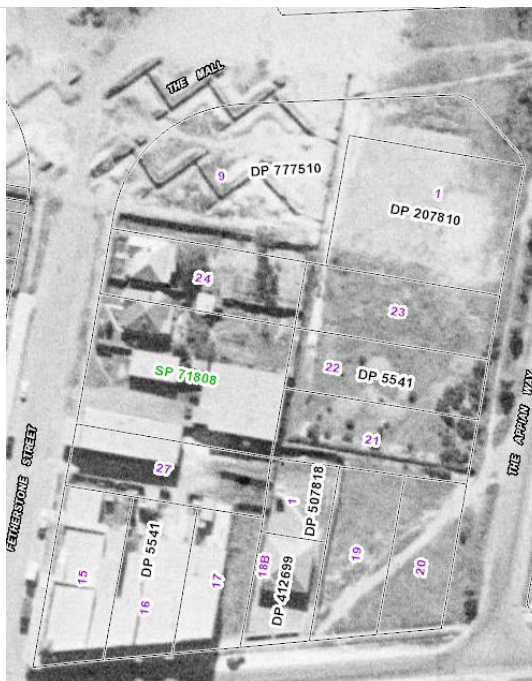
1943¹³

The west section of the site appeared to be occupied by numerous buildings. The buildings in the south-west section appeared to be predominantly commercial/retail. In the north-west section of the site, the landuse appeared to be residential. Trenching which appeared to be on a zig-zag pattern was located in the north-west corner of the site. The north-east and east sections of the site appeared to be vacant and grass covered. A small residential type building was located in the south section of the site.

The immediate surrounds were generally low density commercial/retail with a few scattered residences. Bankstown railway station was located further to the south of the North Terrace.

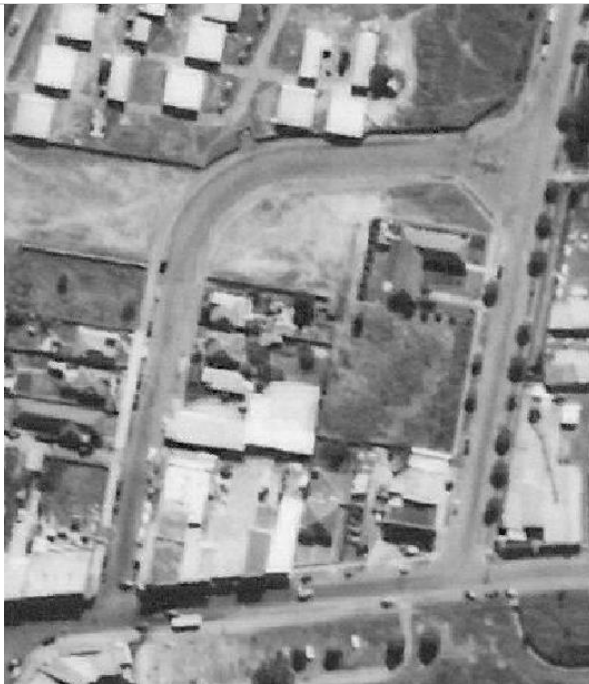
1951

<p>The majority of the site appeared to be occupied by buildings. The buildings on the west section of the site appeared similar to the 1943 photograph. The north-east section of the site was occupied by an 'L' shaped building. The landuse appeared to be predominantly residential and commercial.</p> <p>The immediate surrounds appeared similar to the 1943 photograph.</p>
1961	<p>The majority of the site had been built upon. The landuse appeared to be predominantly commercial/retail. A relatively large building was located in the north-west section of the site which appeared similar to the existing council library. The east section of the site was vacant and grassed.</p> <p>A large shopping centre was located to the east of the site. Paul Keating Park was located to the north of the site beyond The Mall. The immediate surrounds appeared to be occupied by commercial/retail buildings.</p>

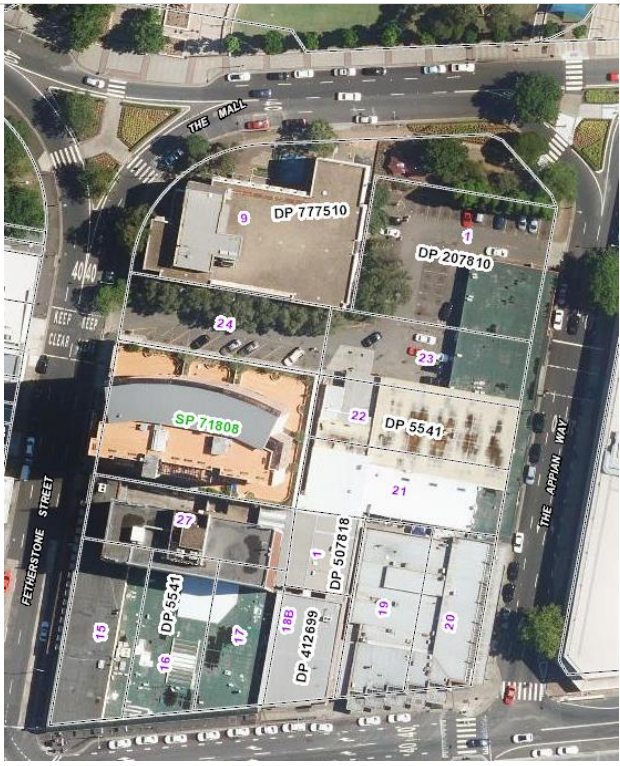
<p>The site appeared similar to the present layout.</p>

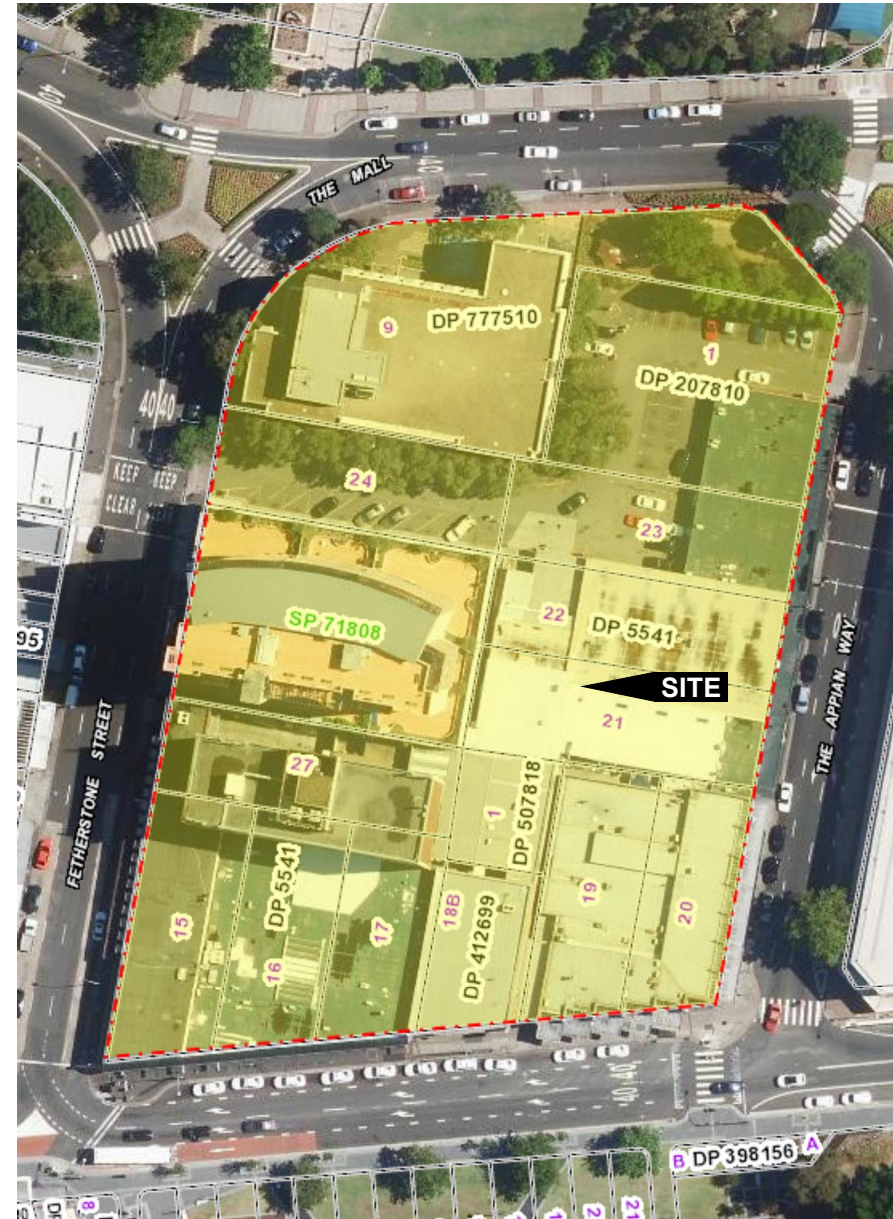
Samples for this investigation were obtained from 3 sampling points as shown on the attached Figure 2. This density is approximately 14% of the minimum sampling density recommended by the EPA. The sampling locations were placed in accessible areas of the site. Sampling was not undertaken in inaccessible areas of the site such as beneath existing buildings.

Completeness
<p><u>Field Considerations:</u></p> <ul style="list-style-type: none"> • The investigation was designed as a preliminary screening and sampling was confined to accessible areas of the site (see Figure 2); • Samples were obtained from various depths based on the subsurface conditions encountered at the sampling locations. All samples were recorded on the borehole logs. All sampling points are shown on the attached Figure 2; • The investigation was undertaken by trained staff in accordance with the SSP; and • Documentation maintained during the field work is attached in the appendices where applicable. <p><u>Laboratory Considerations:</u></p> <ul style="list-style-type: none"> • Selected samples were analysed for a ranged of CoPC as outlined in the SAQP; • All samples were analysed by NATA registered laboratory in accordance with the analytical methods outlined in NEPM 2013; • Appropriate analytical methods and PQLs were used by the laboratory; and • Appropriate sample preservation, handling, holding time and COC procedures were adopted for the investigation.

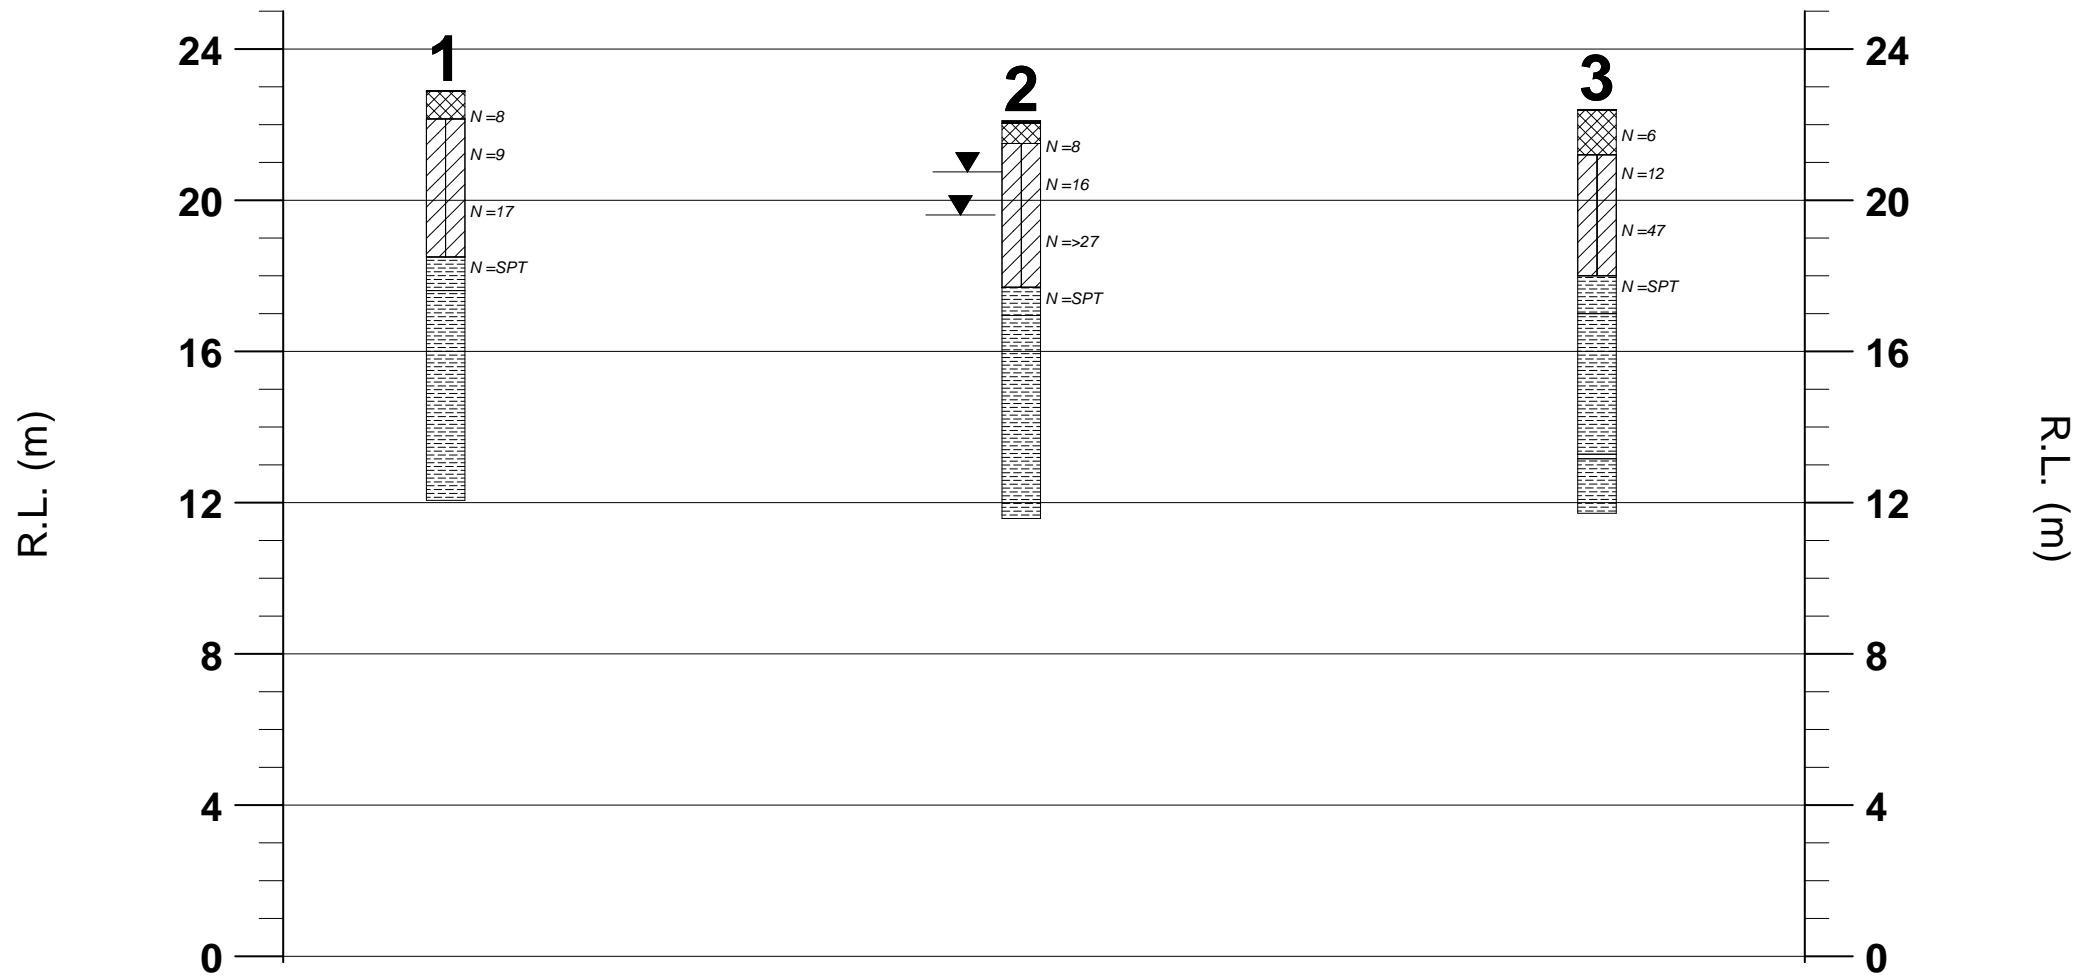
GRAPHICAL BOREHOLE SUMMARY

Asphaltic/Bituminous Paving or Coal
 Fill
 Silty Clay
 Shale
 Core Loss/Empty
 Observed water level
N SPT "N" VALUE
Nc SOLID CONE BLOW COUNTS PER 150mm

NOTE: REFER TO BOREHOLE LOGS
