Ashfield Reservoir WS0003

Conservation Management Plan

Sydney Water Corporation

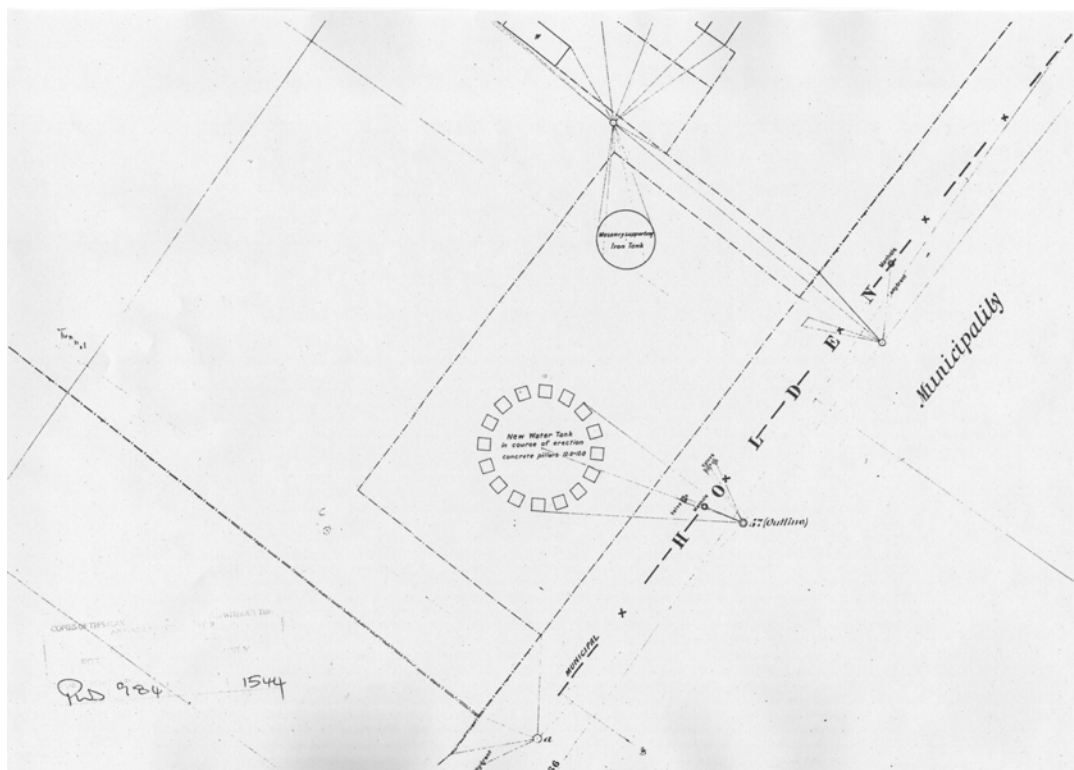
Figure 2-8 Excerpt from Archival Plan PWD Survey 1890

PWD Survey, Syvr J.Duncan A. Riddle 17 Nov 1890, then a large Iron water tank on circular masonry. Revised by Syvr T. Fender 24 Jul 1912 with notation, 'New Water Tank in course of erection concrete pillars'. (Sydney Water Plan Room)

As noted above, Ashfield Reservoir was built on MBWSS Board property next to the original elevated water tank, on the one lot. An archival plan of the Public Works Department Survey (PWD 984) shows the original large water tank on circular masonry, later revised in 1912 to show the position of the new Ashfield Reservoir 'new water tank in course of erection concrete pillars' (Refer Figure 2-8).

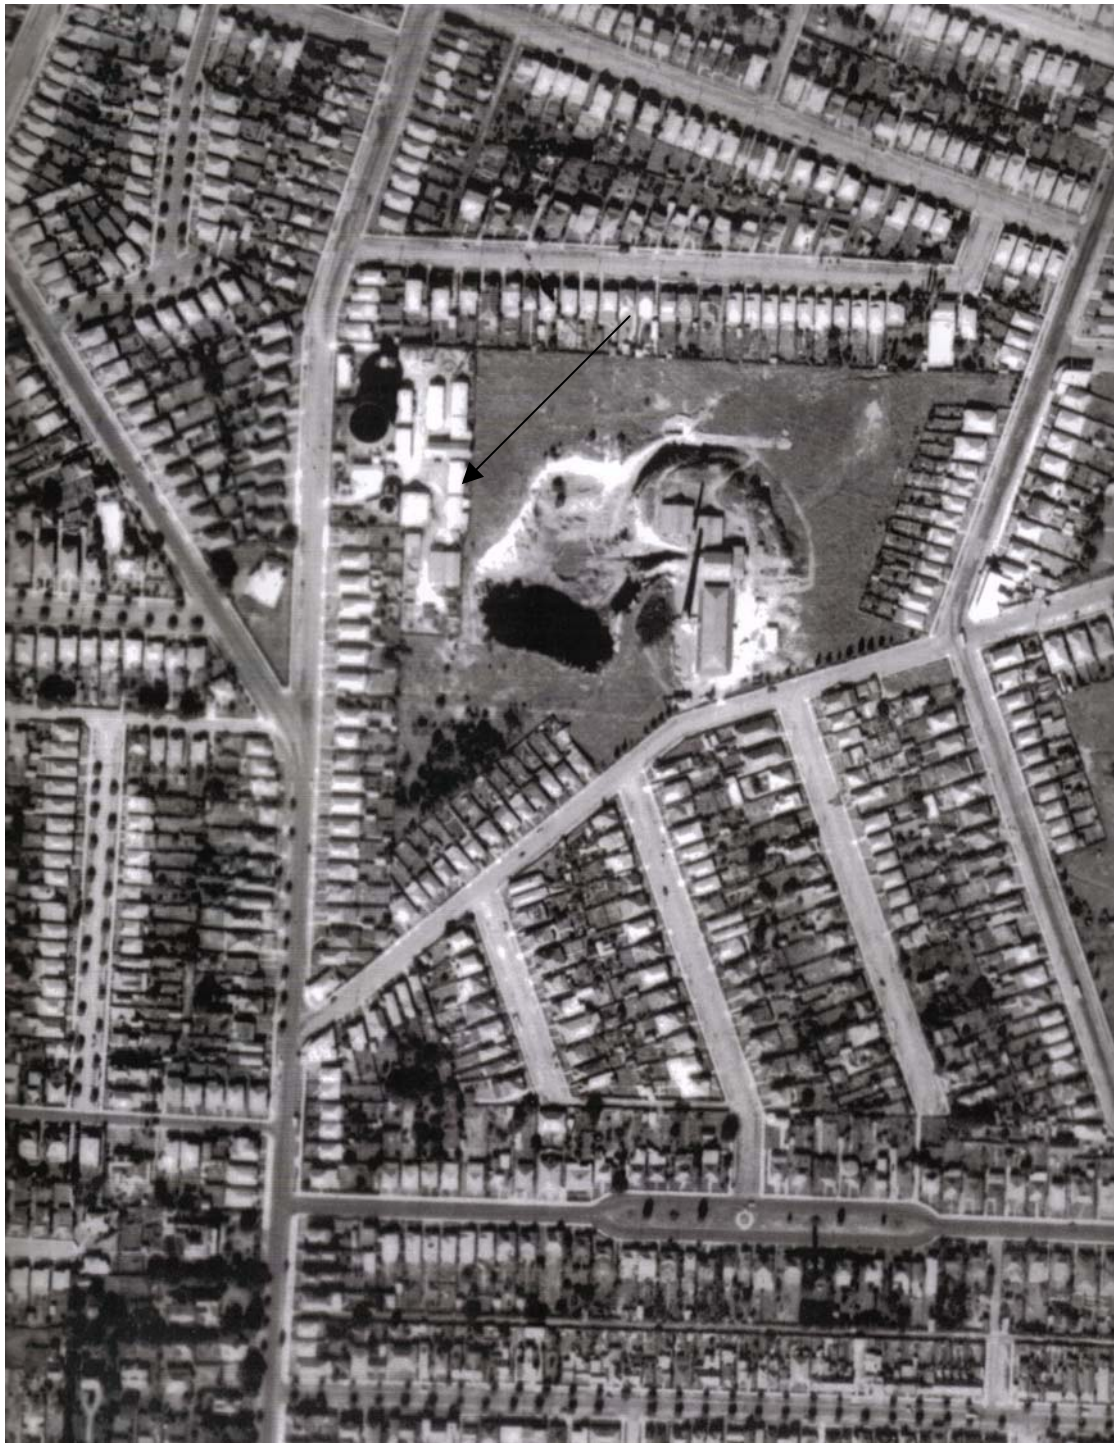
Figure 2-15 1951 Aerial Photograph of the site

The site was also used as a works depot. The 1951 aerial photograph (refer to Figure 2-15) of the site shows that there were numerous buildings and it is likely that these may be associated with the construction of the City Tunnel. With the completion of the project most of the buildings have been removed. The only building that has survived from this time is the galvanised metal shed in the south – east corner of the site.

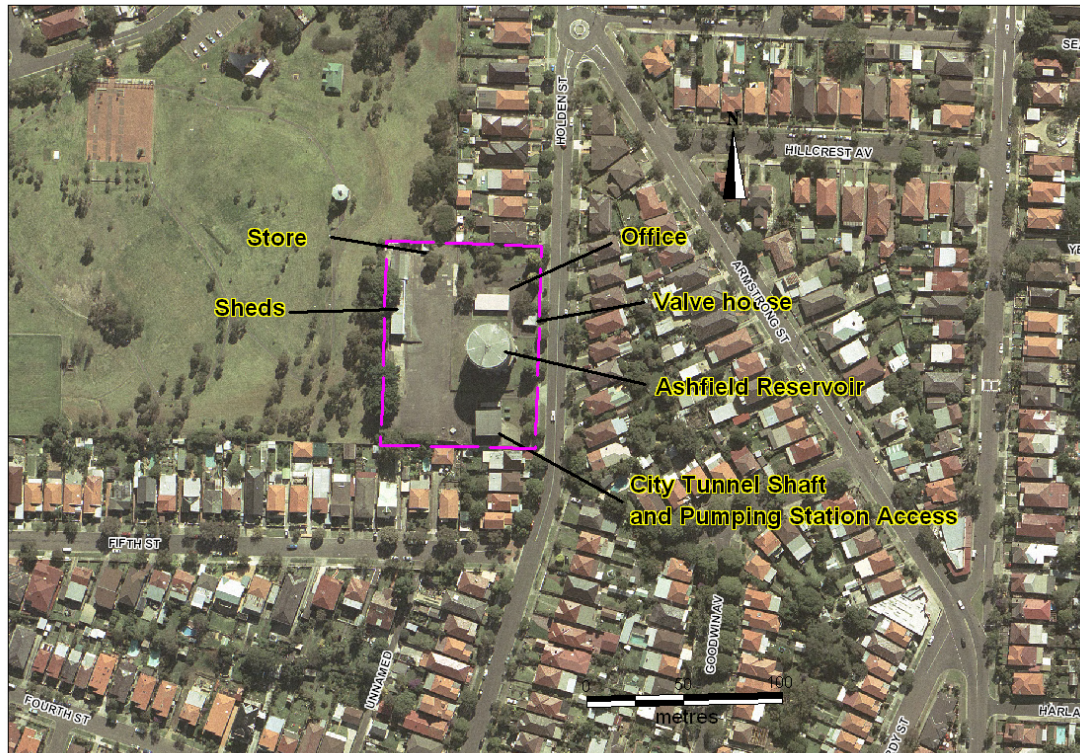
Figure 3-2 Aerial Photo showing the land use surrounding Ashfield Reservoir and the layout of the built items within the site.

The layout of the built items within the site is shown in Figure 3-2. The north side of the block includes several brick, skillion- roofed office, amenity, workshop and garage buildings. These buildings were used as a works depot site. A large asphalt paved car park is sited to the west of the Reservoir. The south side of the block features a fenced electrical substation. A small brick valve house is located on the boundary of Holden Street, an adjacent to the Reservoir.

The general layout of the built components of the site is shown in Figure 3-2. The site includes a valve house, workshops and offices (described in Table 3-2), as well as access to the City Tunnel and pumping station.

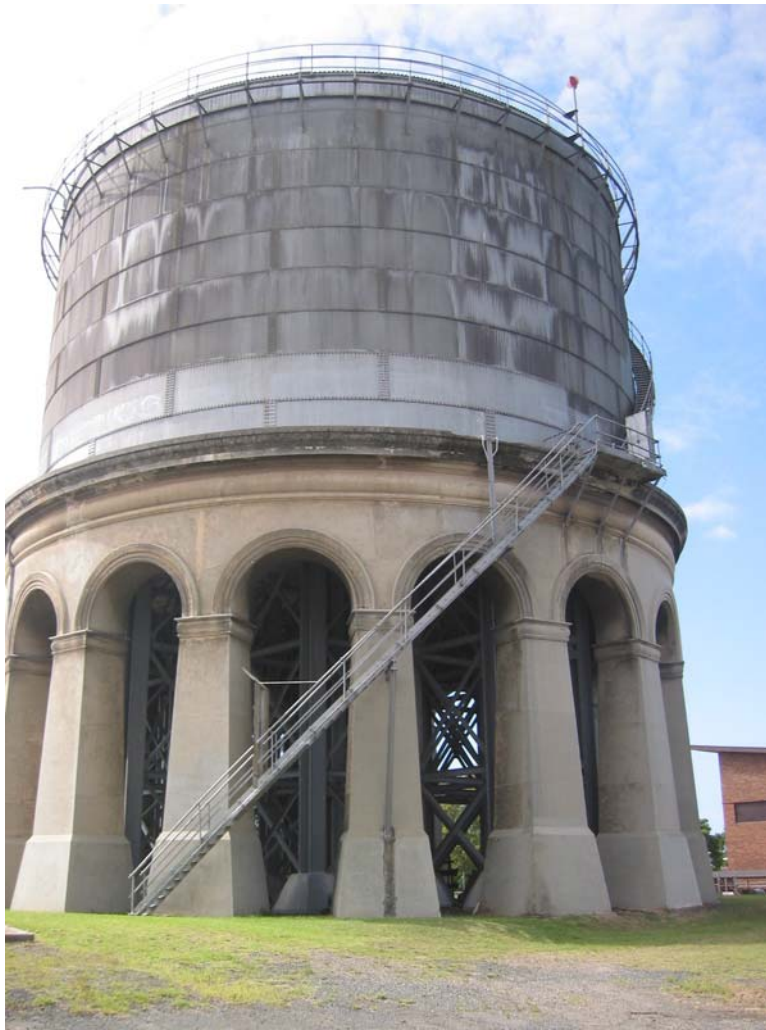
Figure 3-6 Western view of Ashfield Reservoir showing the lower stairs and landing.

Note the absence of planks from the walkway below the top of the tank.

Ashfield Reservoir (Elevated) (WS 0003) is an elevated cylindrical riveted steel tank, resting on a concrete apron and supported on a steel girder frame. The perimeter is a ring of mass concrete columns linked by semicircular arches.

The steel tank has nine rows of steel plates welded and riveted, the horizontal seams are lap jointed with a single row of rivets. The vertical seam use fishplates and four rows of rivets, the space between each rivet widening from top to bottom. The expansion joint is likely to be a bituminous coated lead ring gasket in a cast-iron seating.

The timber decking has been removed from the walkway and not replaced. The walkway frame is attached to the outside of the top row of the steel plates, approximately 1m below the top. This walkway is attached to the tank wall and by short steel braces. The light metal handrail of the walkway remains in place.

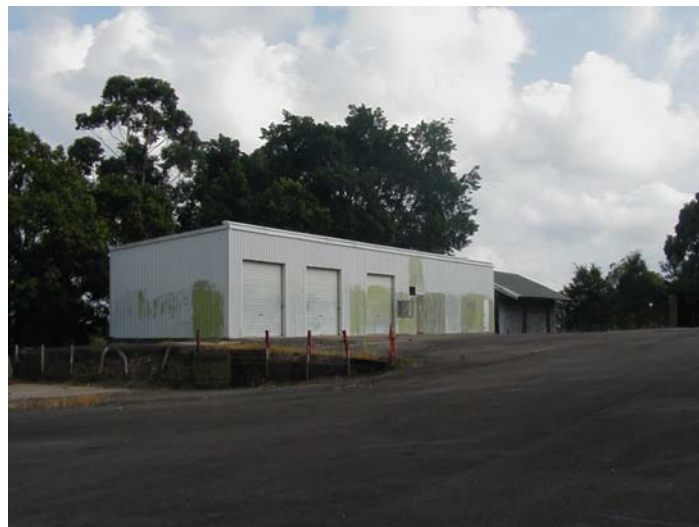
Sheet metal shed associated with the use of the site as a maintenance depot- now disused. Three roller doors on the southern end of the building indicate that it was used as garage.

Embankment on the southern side of the building likely to have been used as materials store area.

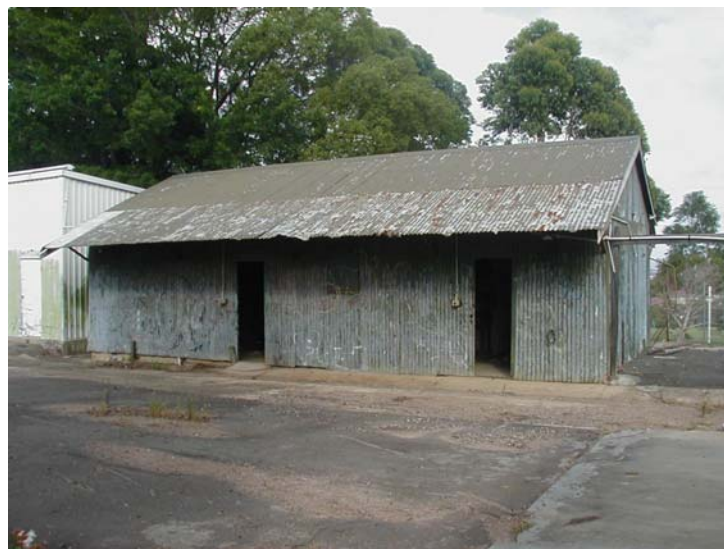
Corrugated iron shed workshop on the western side of the site. Simple construction of corrugated iron on a timber frame, gabled roof.

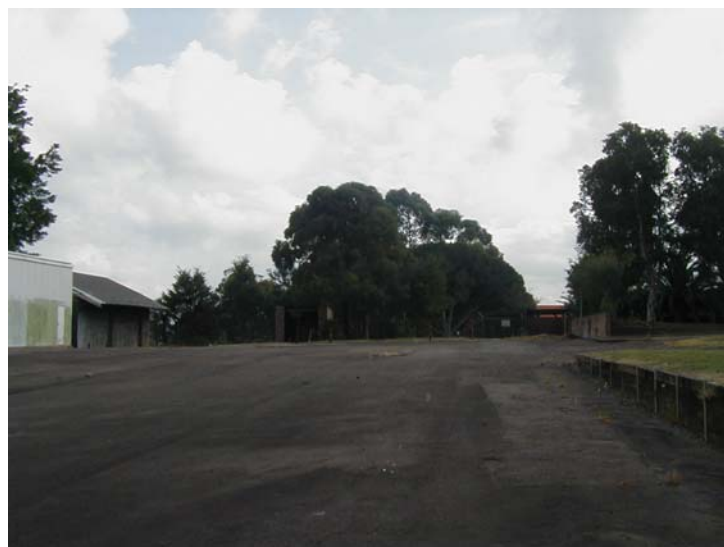
Large area of asphalt to the west of the site

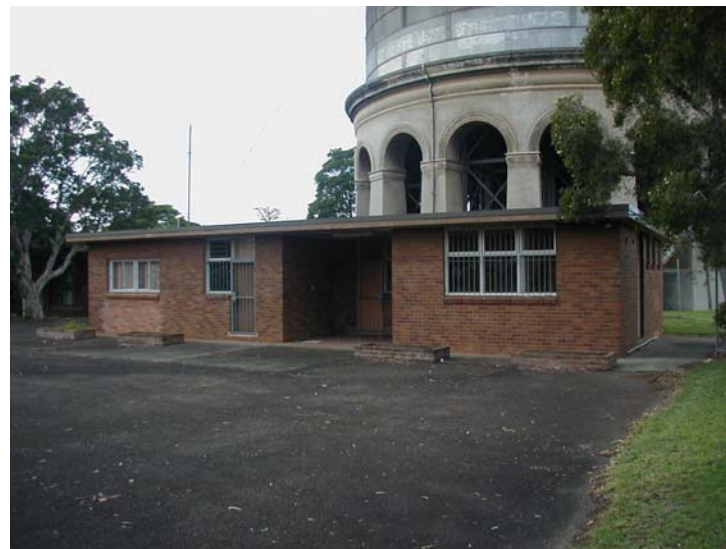
Office Building

Small modern office and amenities building- red brick, skillion roof. Situated on the site to the north of the reservoir.

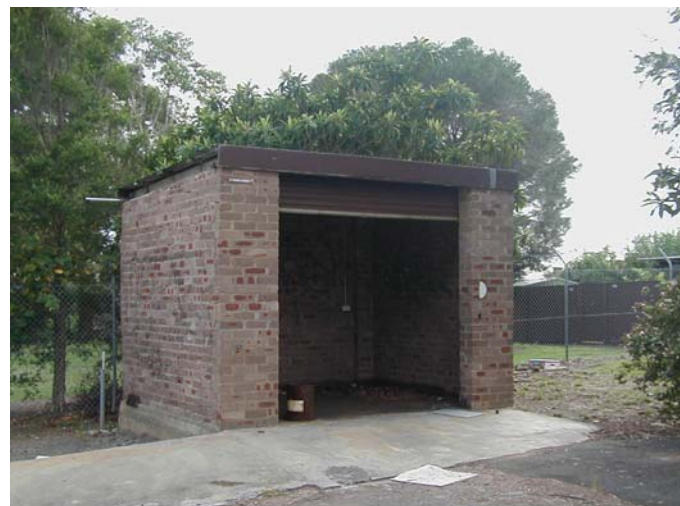
Store

Small brick building with roller door – likely to have used as a store close to the northern boundary of the site

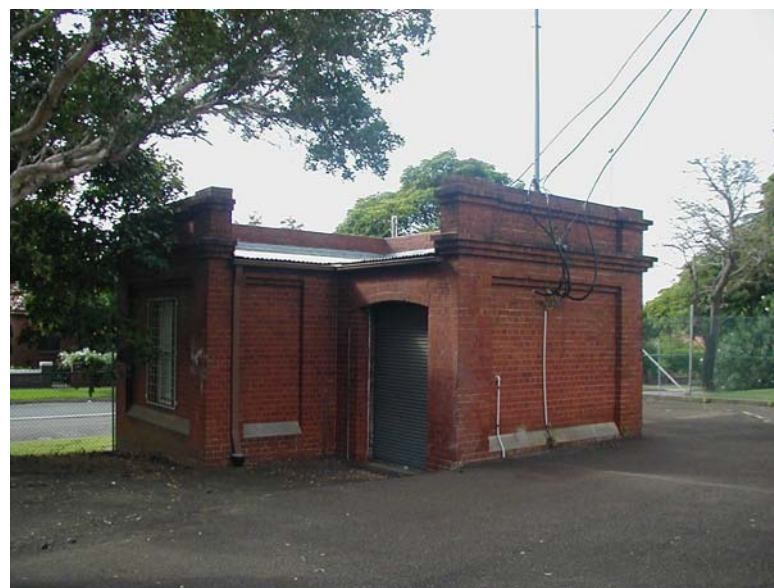
Valve house- Masonry brick building, skillion roof that is hidden by parapet. The parapet has a decorative course of cantilevered bricks at the top and an under cornice consisting of 3 courses of cantilevered profiled bricks.

Eastern and western elevations of the building have blind recesses with cement rendered sills.

Northern elevation has roller door that replaces the original double hung wooden doors. Windows on the southern and

<p>northern sides have metal grills and have been boarded up. Originally these windows were double hung with arched lintels. Now houses Police communication control equipment – cabling and antennae evident.</p> <p>Pipework and valves are in the lower level of the structure</p>

Alterations to the Valve House include the replacement of wooden double hung doors with a roller doors, the installation of metal grills on the windows, the installation of cabling, antennae etc for the additional use of the building for police communication.

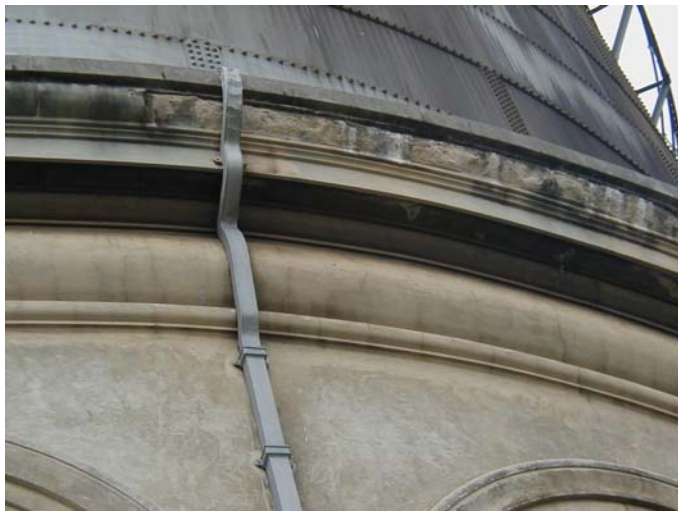
<p>A) Reservoir substructure-Mouldings have broken away</p>

Figure 3-7 **Some aspects of the Condition of the Reservoir**

Reservoir Substructure-Render/Concrete		Mouldings have broken away in some areas-worst on the northern side
Reservoir Substructure – Concrete Columns /Arches		Single radial direction cracks found through the soffit of some arches Generally in good condition Render patched in places
Reservoir Substructure – Steel Framework		Steel framework generally in good condition
Other		There is no bird netting to the substructure and pigeons are using the area for roosting Down pipes –paint flaking and corrosion Graffiti has been a problem in the past and cleaned areas are obvious

There is evidence of some deterioration of the fabric such as, render loss of the concrete sub structure, and corrosion and staining of the steel elements. This has been described in section 3 of this report.

Deterioration of the render is also identified as a safety concern, as falling render constitutes a risk to those on the site.

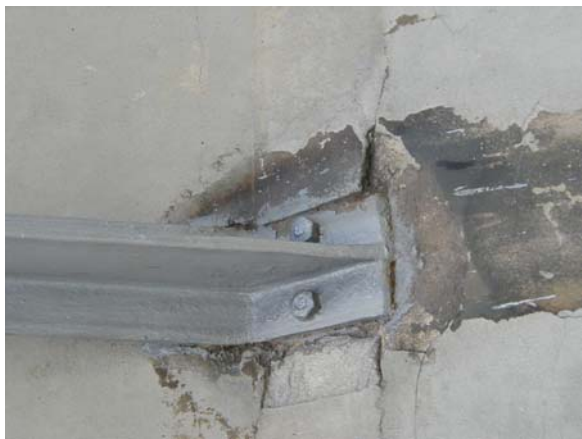
<p>B) Stair bracing – signs of corrosion and concrete spalling at attachments</p>

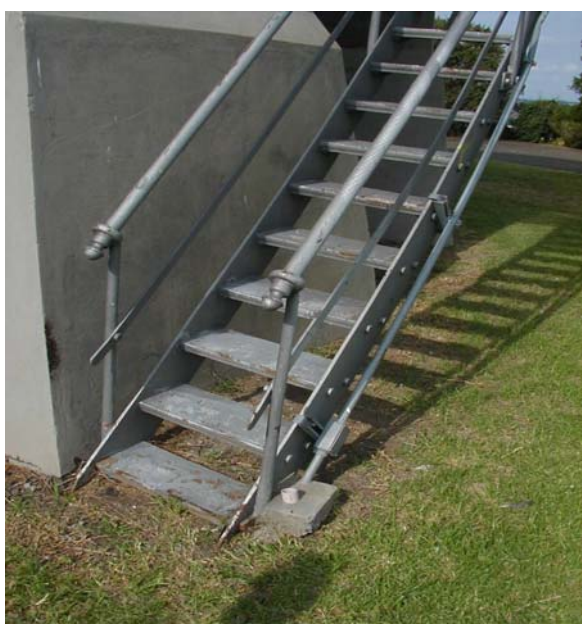
<p>C) Stair - Signs of corrosion on the treads</p>

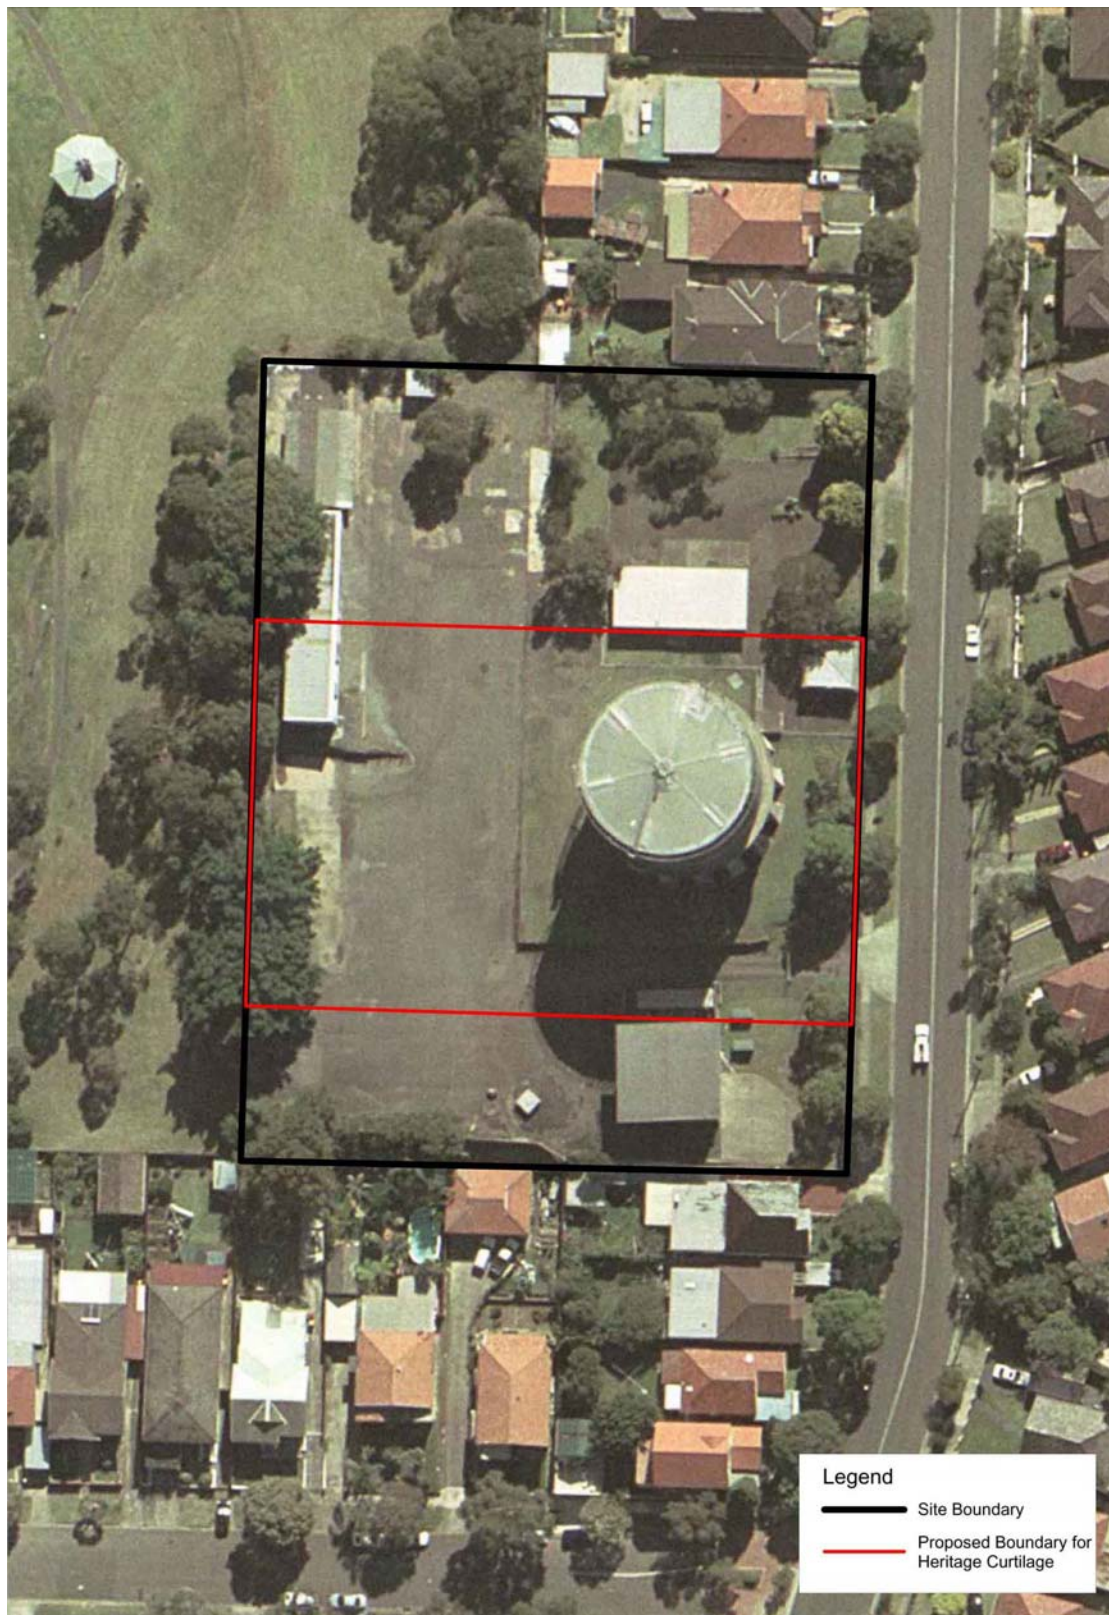
Figure 6-1 Proposed boundary for heritage curtilage

The site is owned by SWC and has until recently been used as a works depot. The site as a depot is now surplus to need and SWC is investigating the sale of part of the site. Consideration of the future needs for an additional reservoir at the site is being undertaken prior to a firm decision being made about property disposal. The location of the any future reservoir is likely to be the southwest corner of the site. Also prior to the land disposal an investigation of the levels of soil contamination would need to be undertaken.

Sydney Water intends to undertake a detailed survey and proposed changes to the curtilage will be undertaken in accordance with the requirements of the legislation and the Heritage Office.
