Site Audit Report

0503-2103

165 -169 Holden Street  
Ashbury NSW

60565/137967 (Rev 0)

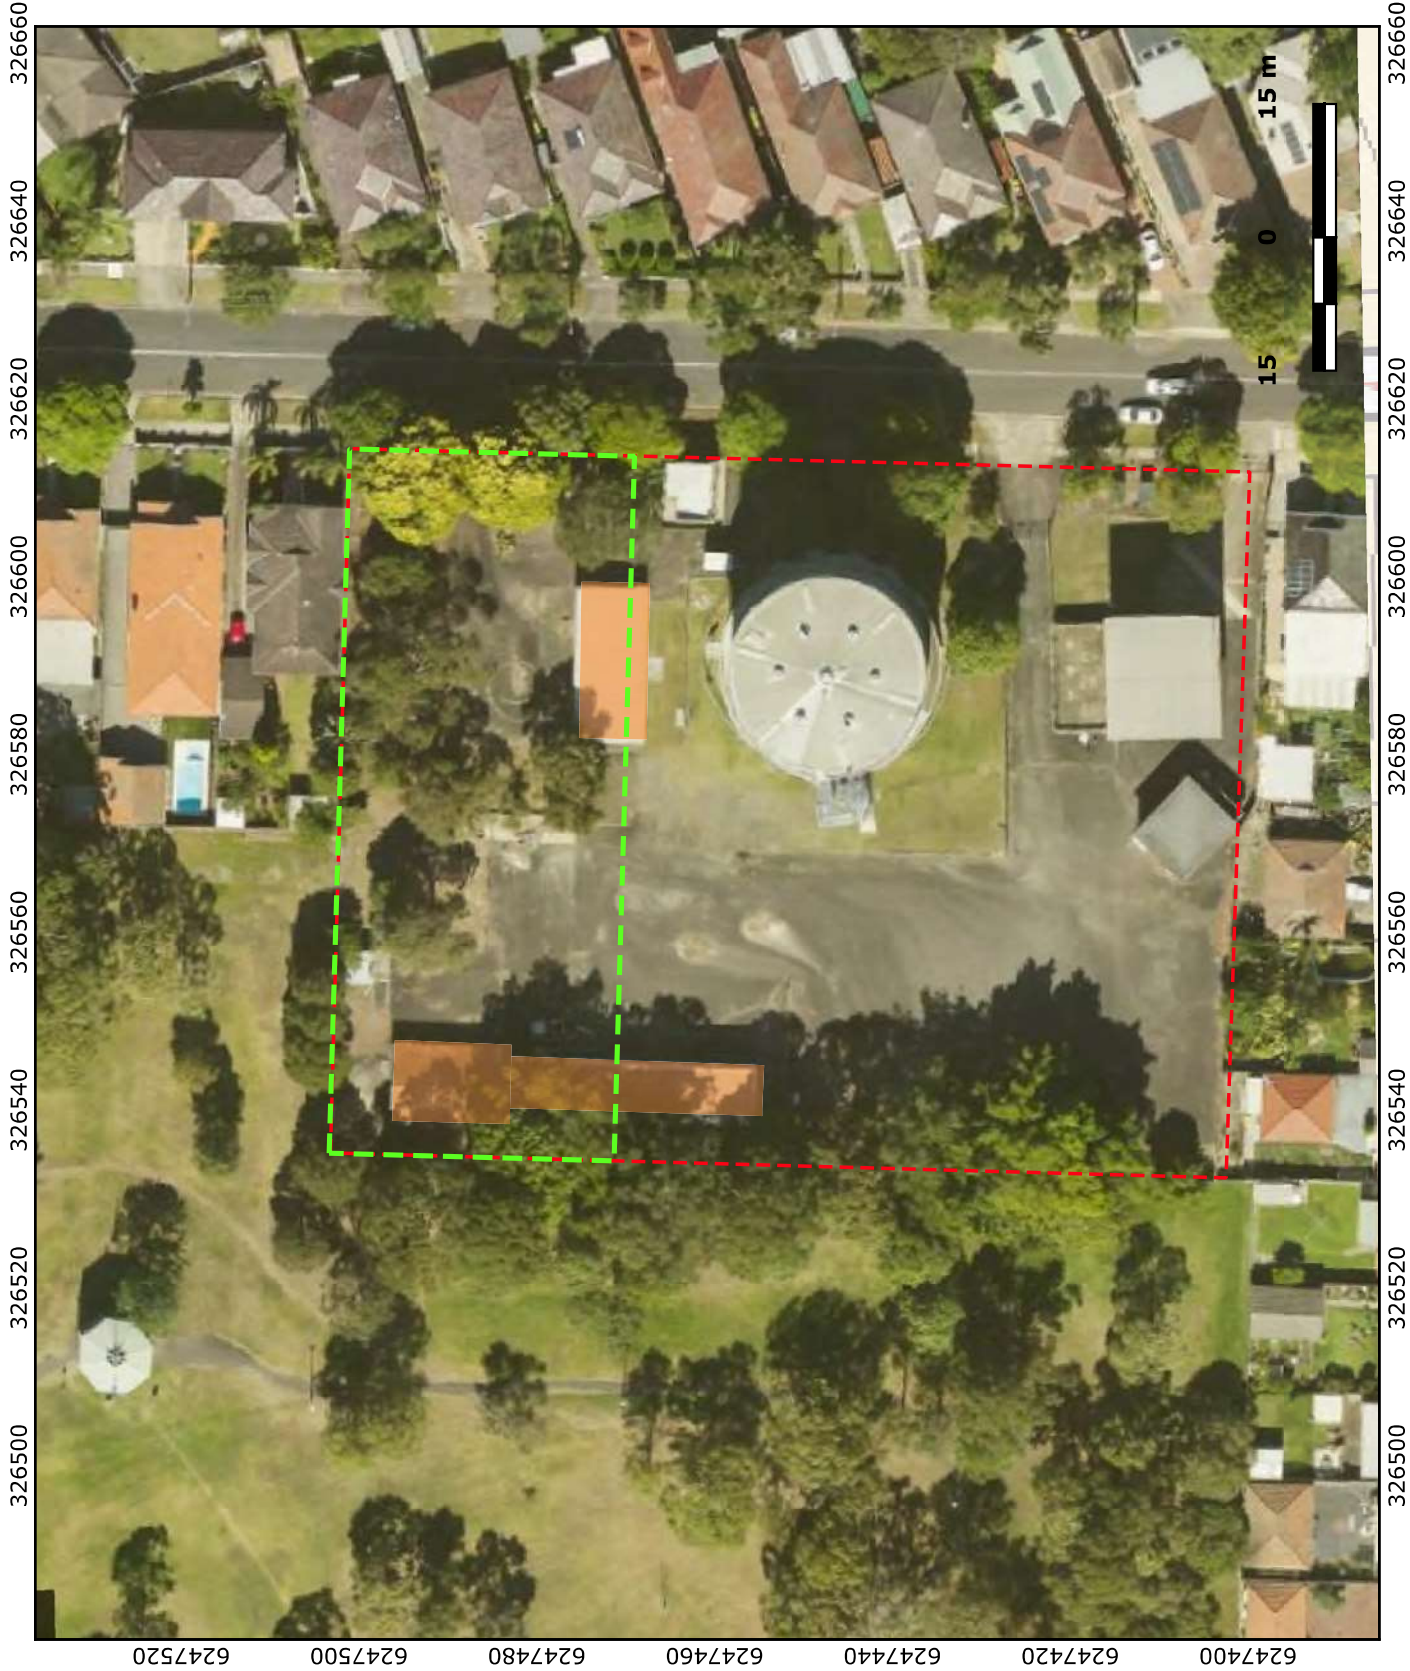
Project Reference	P034963.001		
Report Name	Remediation Action Plan		
Client	Sydney Water		
165-169 Holden Street, Ashbury NSW			
Figure 2 Site Layout

PROGRESSIVE RISK MANAGEMENT			
Scale: 1:850			
Coor. Sys: GDA 1994 MGA Zone56			
<div>Legend</div> <div>  Site Boundary (disposal area)</div> <div>  Approximate Sydney Water Property</div> <div>  Inaccessible Areas (buildings)</div>			
 			Image Source: Metromap (2020)
